**DEVELOPMENT AND APPLICATION
OF A SALMON HABITAT RESTORATION FRAMEWORK
ON THE
NOME RIVER WATERSHED, ALASKA**

June 2005

**M.N. Gaboury, R.B. Murray and R.C. Bocking
LGL Limited
environmental research associates
9768 Second Street
Sidney, BC V8L 3Y8**

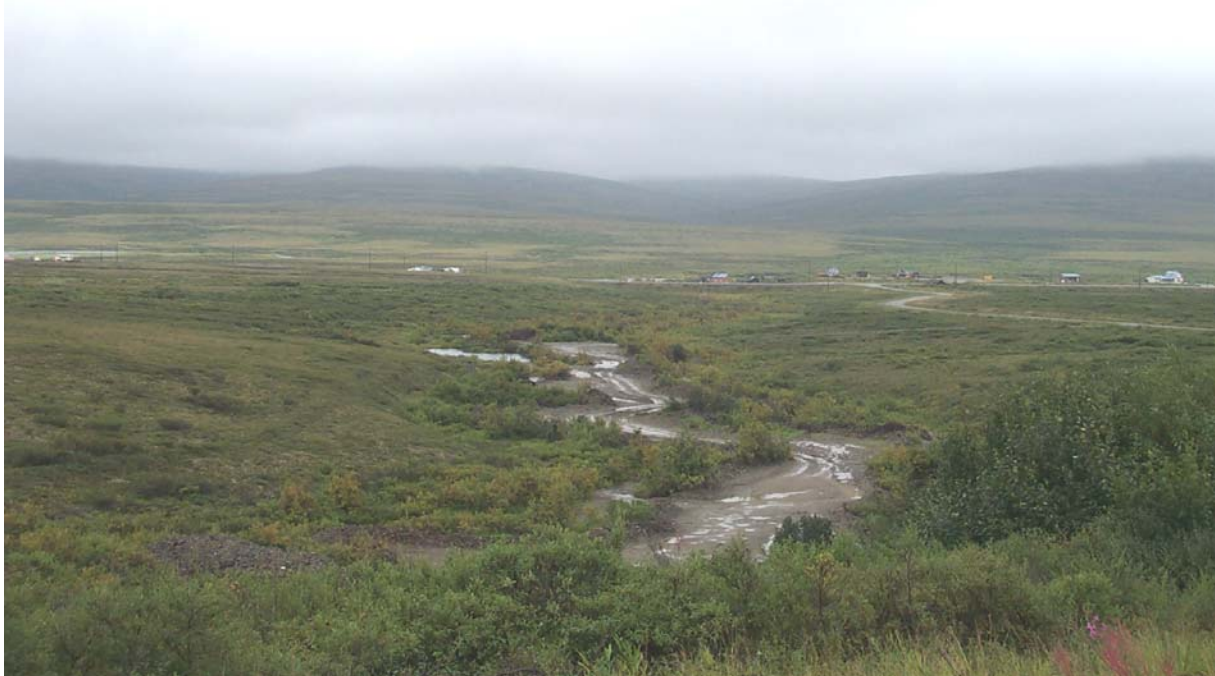
Photo 1. Looking downstream at the vehicle trails within the wetted channel of Dexter Creek. Historic placer mining and use of the channel by vehicles has degraded fish habitat.

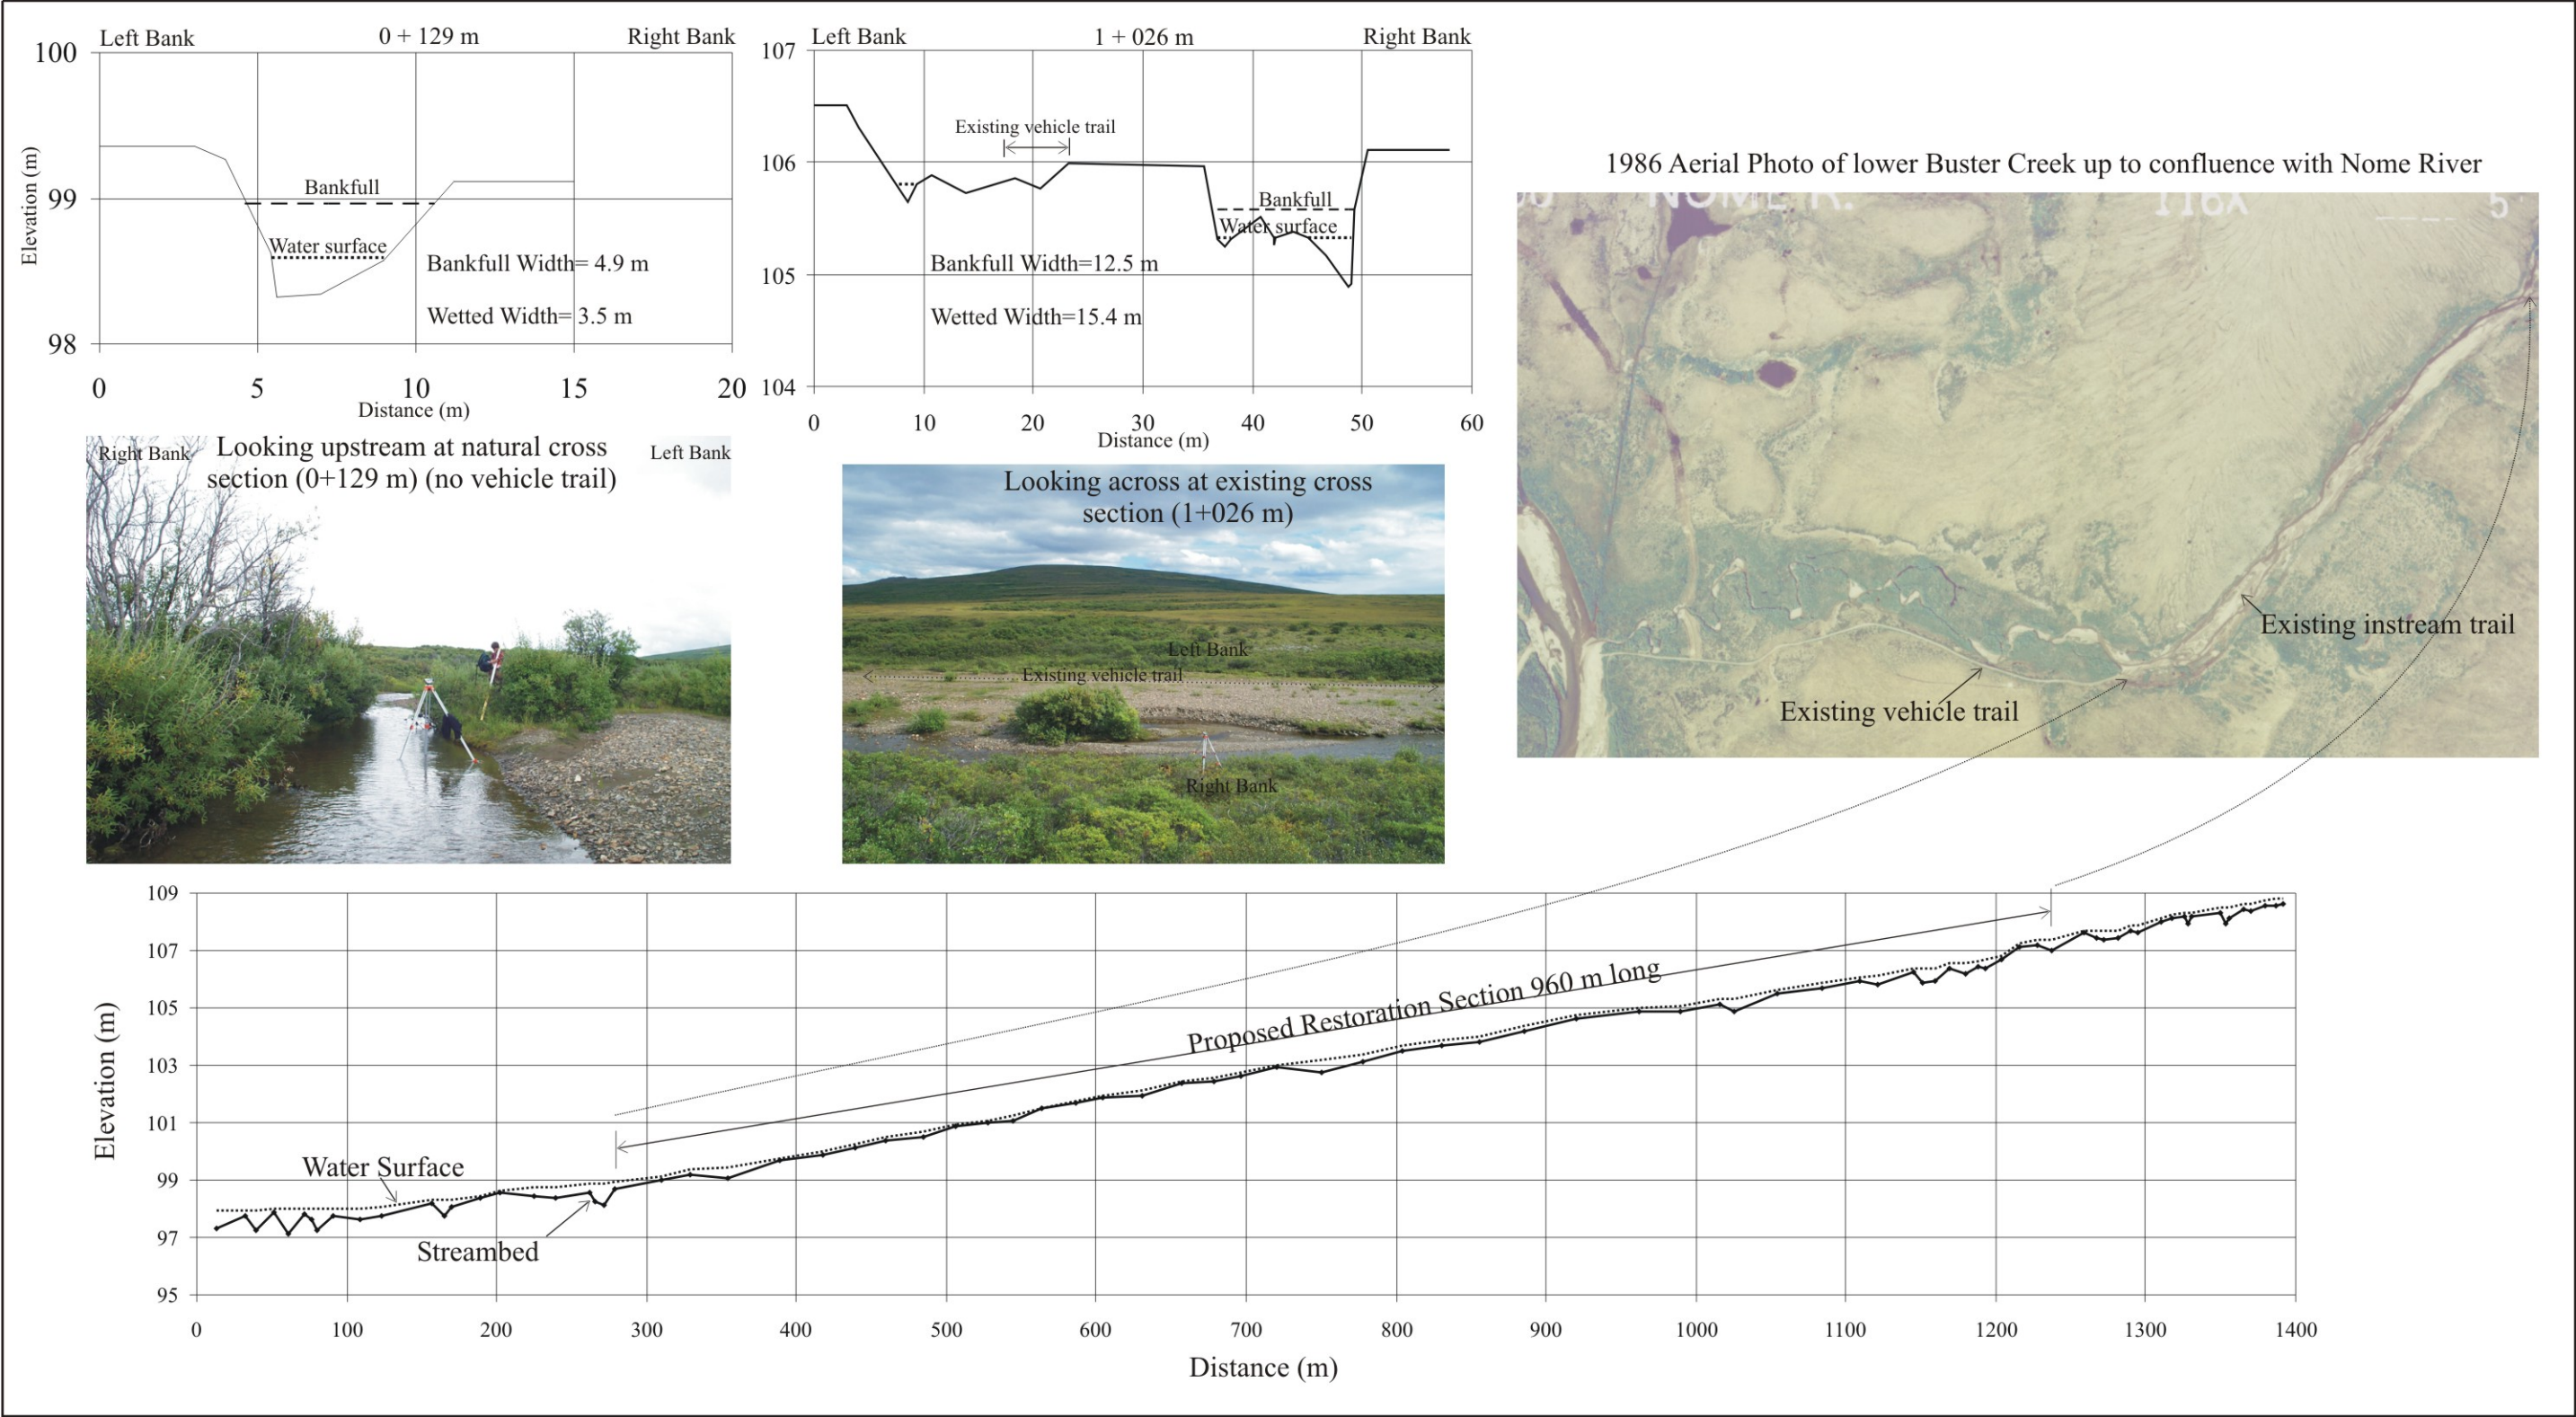
Figure 6. Aerial photo view, existing cross sections and streambed profile of Buster Creek showing proposed restoration section.

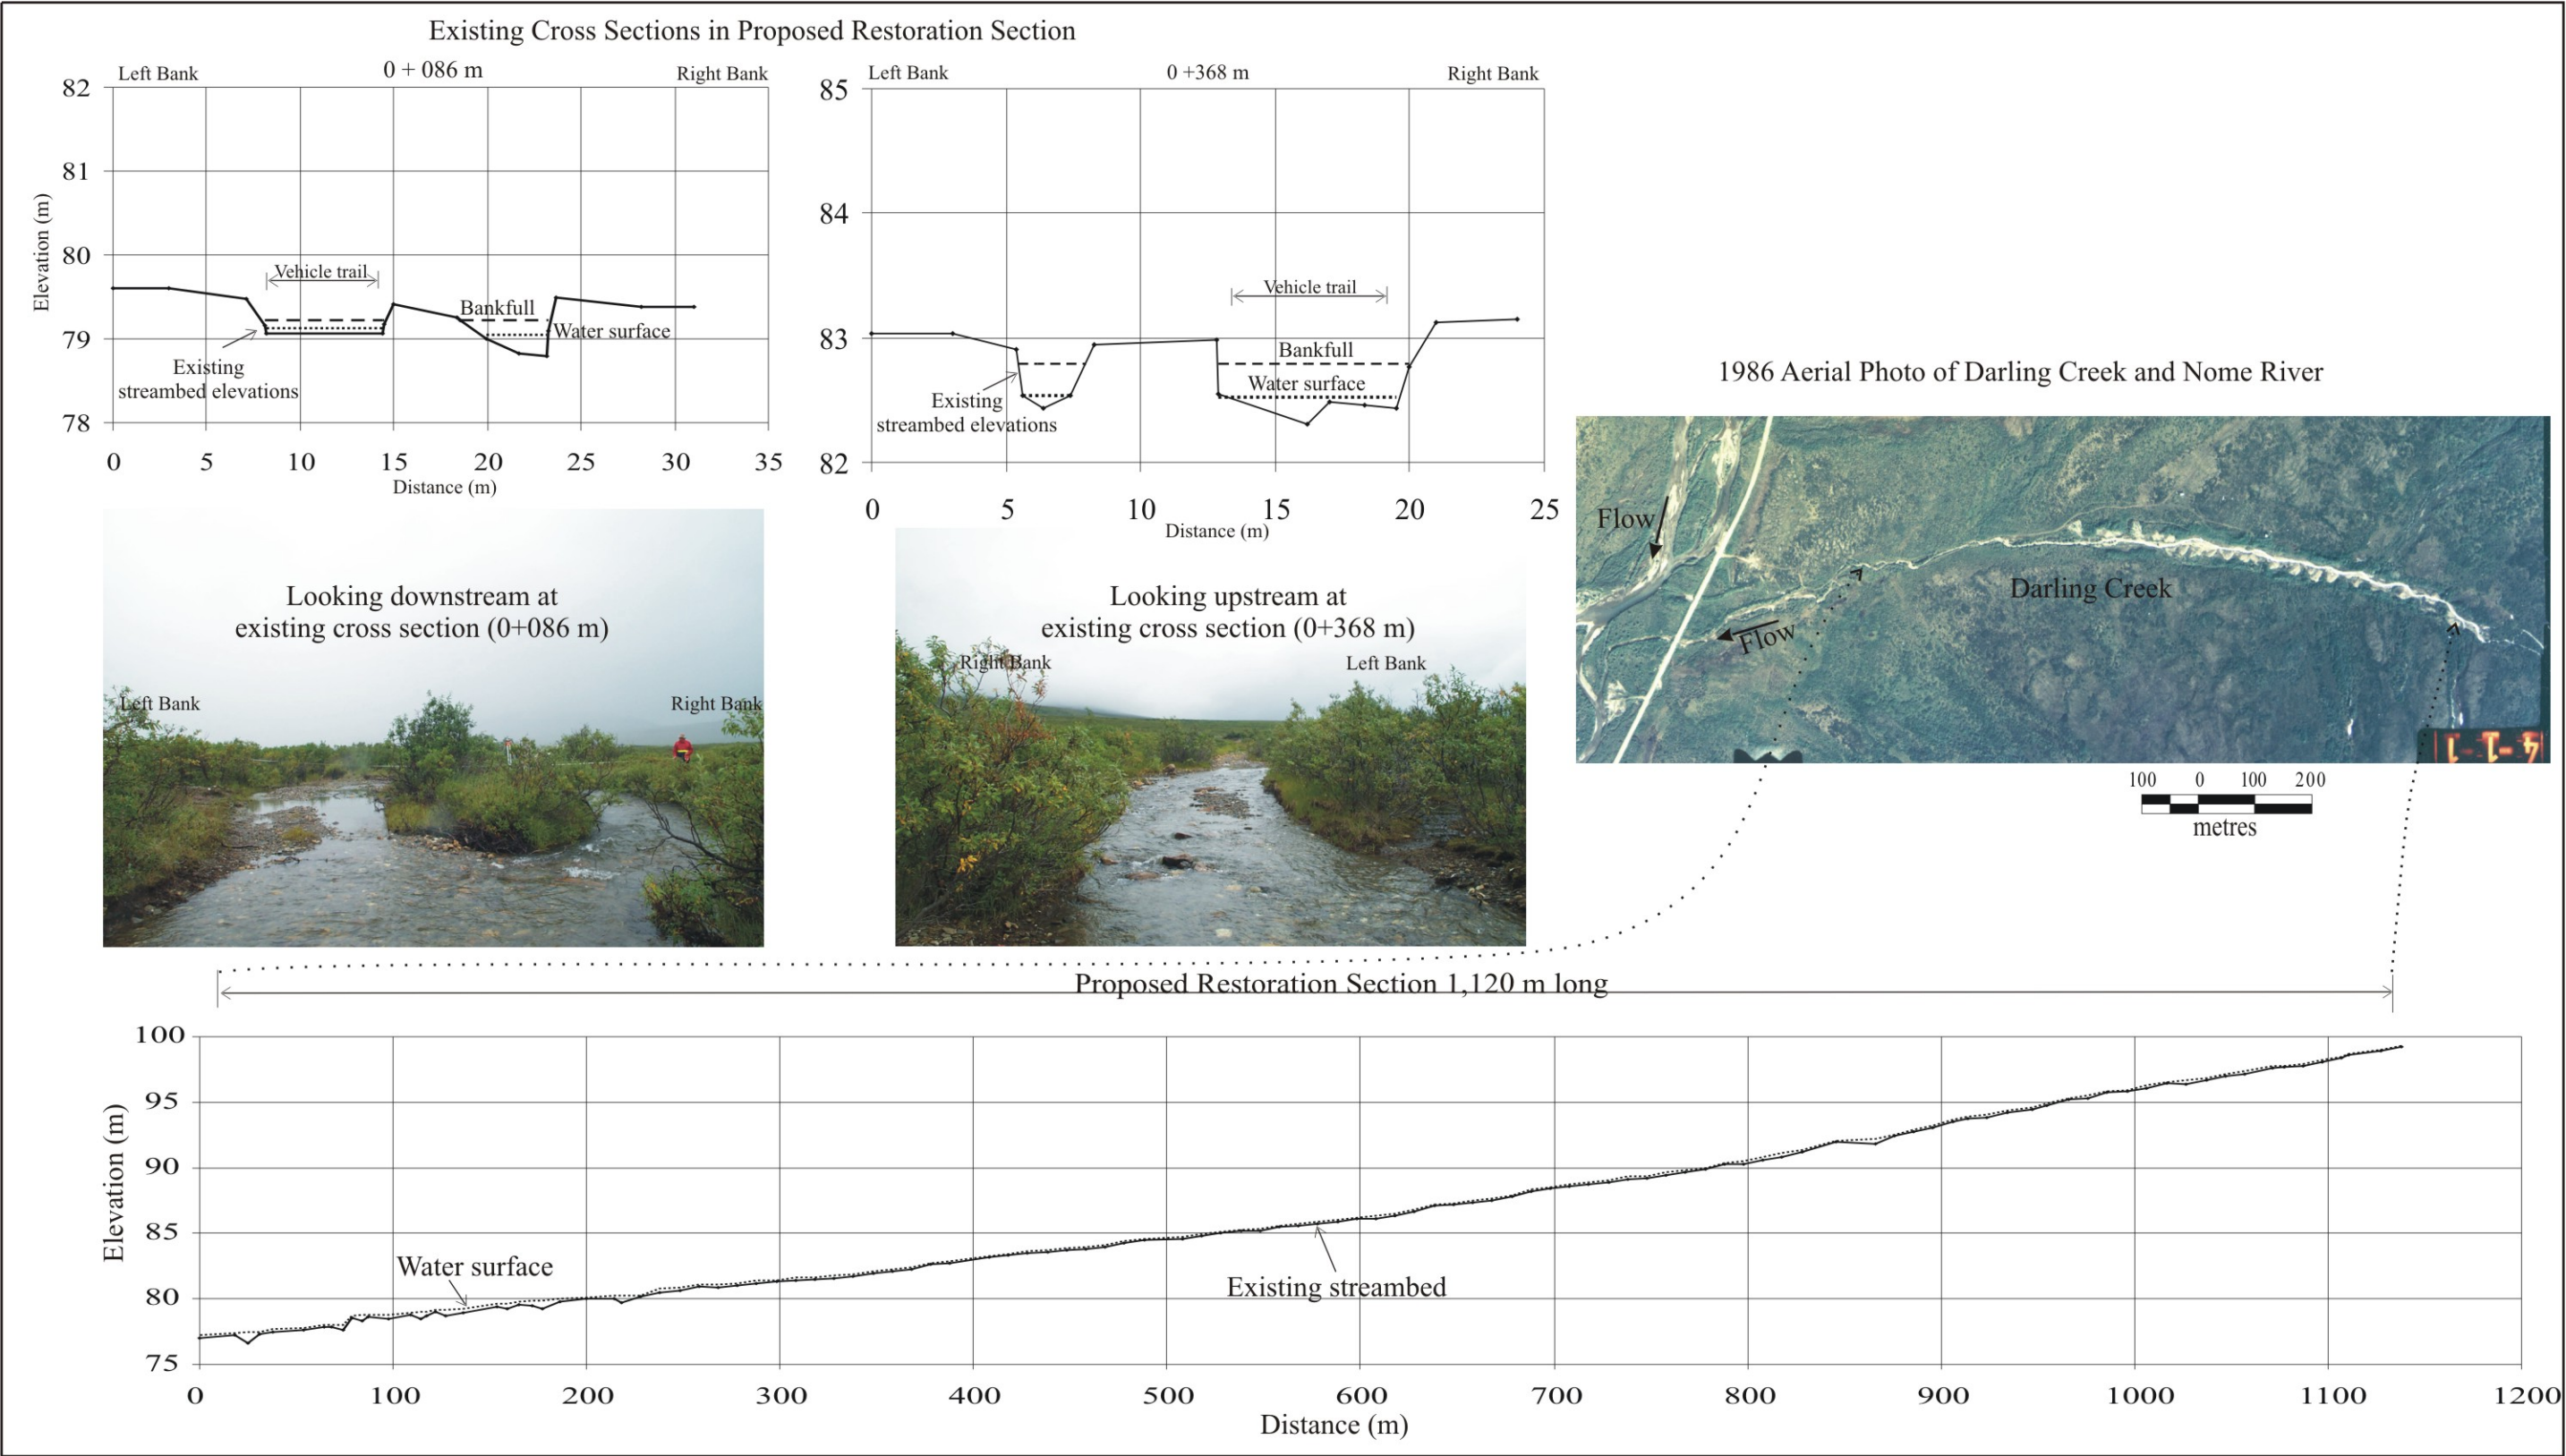
Bed paving materials were measured at chainages 0+622 and 1+595 m (Appendix H). Median (50%) diameters for the existing bed material were 8 and 13 cm, respectively. The median sized bed material would be stable at a bankfull discharge. This assumes a mean bankfull depth of flow of 0.31 m in the shallow, over-widened channel and an average gradient of 1.9%.

Figure 11. Aerial photo view, existing cross sections and streambed profile of Darling Creek in proposed restoration section.

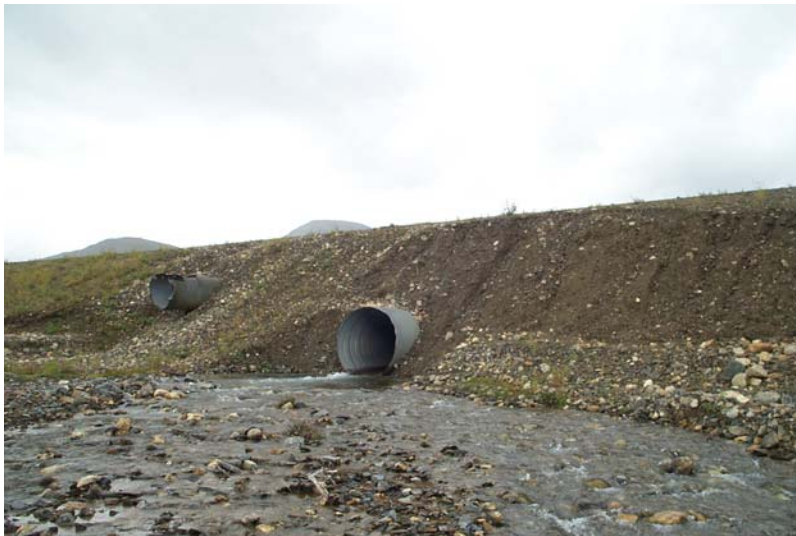
Side slopes at culvert crossings along the Nome-Kougarok Road are chronic sources of sediment to the stream (Photo 3). To alleviate sediment erosion at culvert crossings, side slopes along roads should be 1.5H:1V and include riprap protection (Poulin and Argent 1997). The culvert should be long enough to extend one culvert height beyond the side slope on the upstream side and 1.5 culvert heights on the downstream side. As a general rule, culvert lengths of 18-30 m should be sized to ensure an average velocity of 0.6 m/s during the period of juvenile fish migration and 0.8 m/s during the period of adult migration.

Photo 3. Looking upstream at eroding side slope of Nome-Kougarok Road at Rocky Mountain Creek culvert crossing.

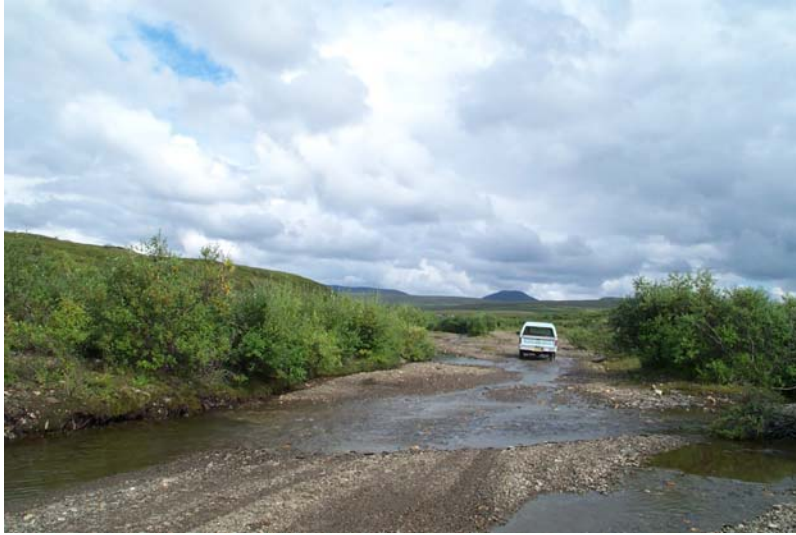
Vehicle trails within the wetted perimeter of streams cause over-widening, habitat simplification and increased erosion and sedimentation (Photo 4). Frequently used vehicle trails should be located outside of the channel and riparian zone, with a setback distance from the top of bank or high water mark of generally 15-30 m.

Photo 4. Historic use of the wetted channel in Buster Creek as a vehicle trail has over-widened the channel and degraded fish habitat.

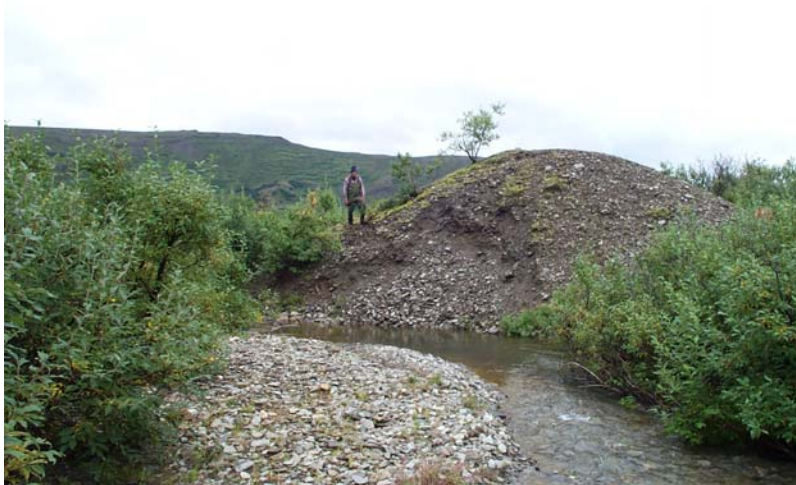
Placer mine tailings that are piled along many of the Nome tributaries are being eroded, contributing significant volumes of sand and gravel that aggrade downstream pool and riffle habitats (Photo 5). For example, eroding tailings piles are contributing sediment to Hobson, Clara, Buster, Darling, Dexter, Reach N7 of Nome River and other streams. The tailings piles are typically poorly vegetated because of their coarse composition and height above the water table. The tailings should be stabilized by lowering the top of the pile to the floodplain elevation, re-grading the side adjacent to the stream to a 2H:1V slope, and planting the surface of the tailings with native willow. A finer planting medium may also be required for the surface of the tailings. If necessary, the planting soil should be placed to a thickness of about 0.3 m.

Photo 5. Sloughing placer mine tailings adjacent to Clara Creek.

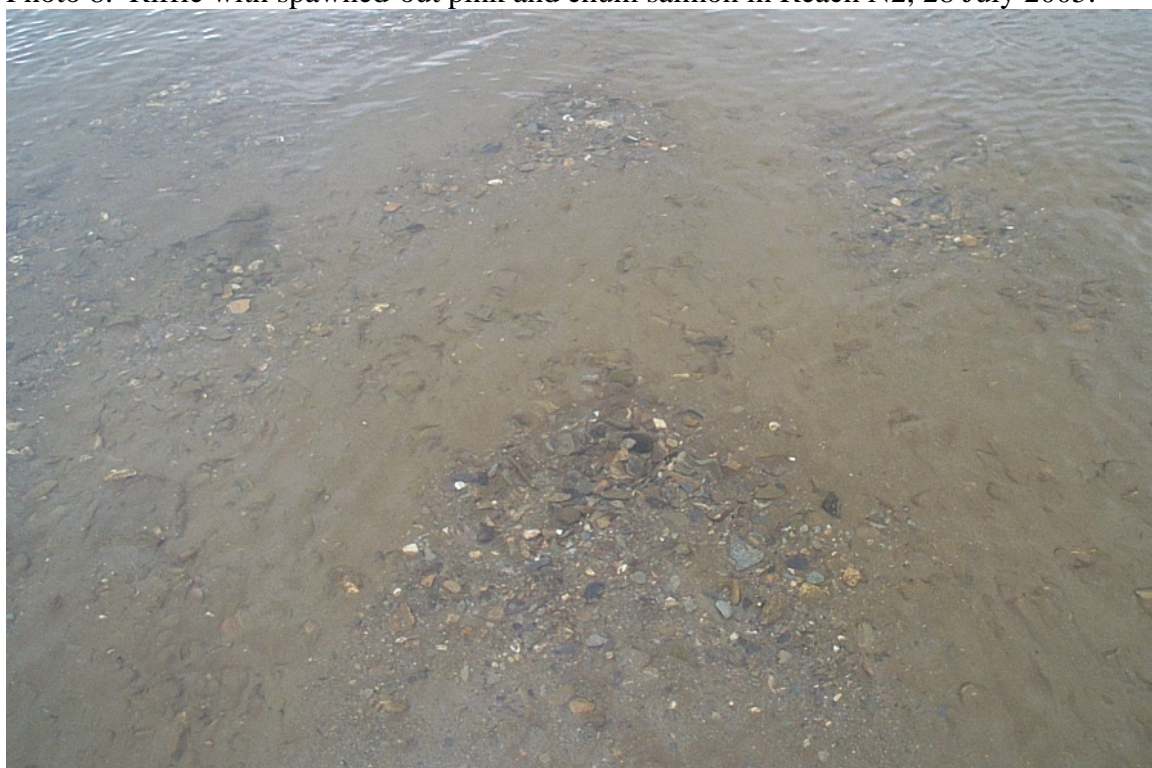
Photo 9. View of silt decomposition on potential spawning substrate on right side of channel in Reach N2 downstream of culvert run-off from Nome-Kougarok Road.

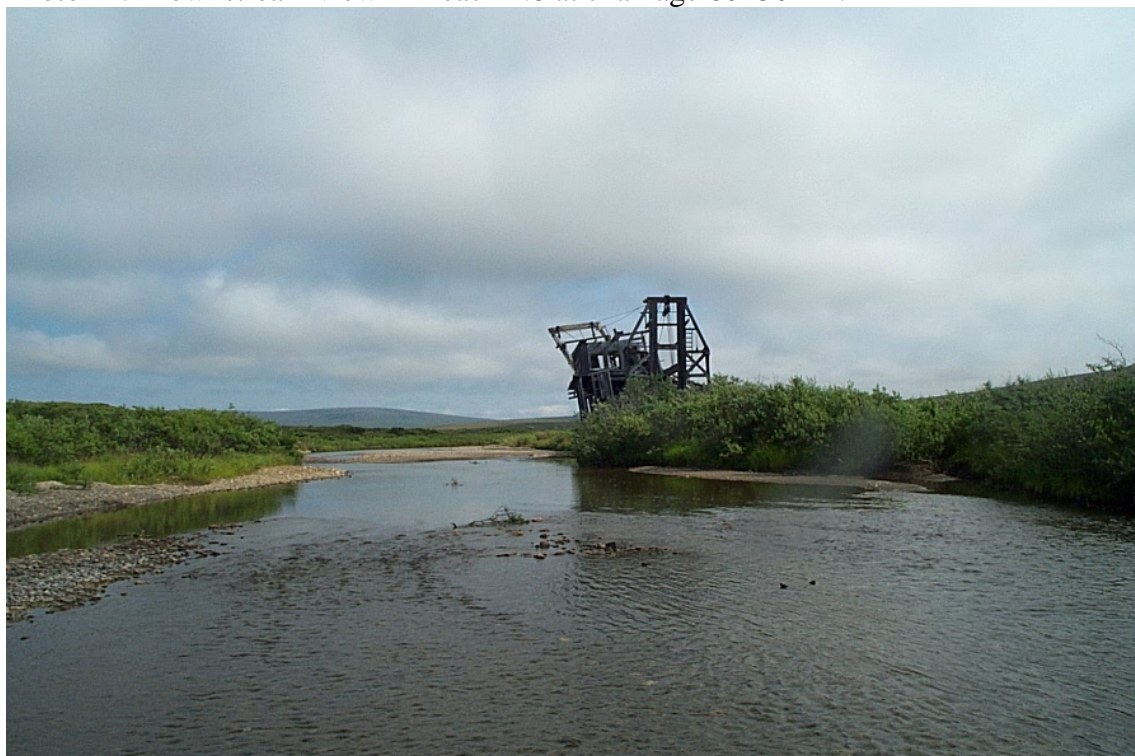
Photo 22. Upstream view in Osborn Creek at aggraded, over-widened channel with virtually no instream cover attributes.

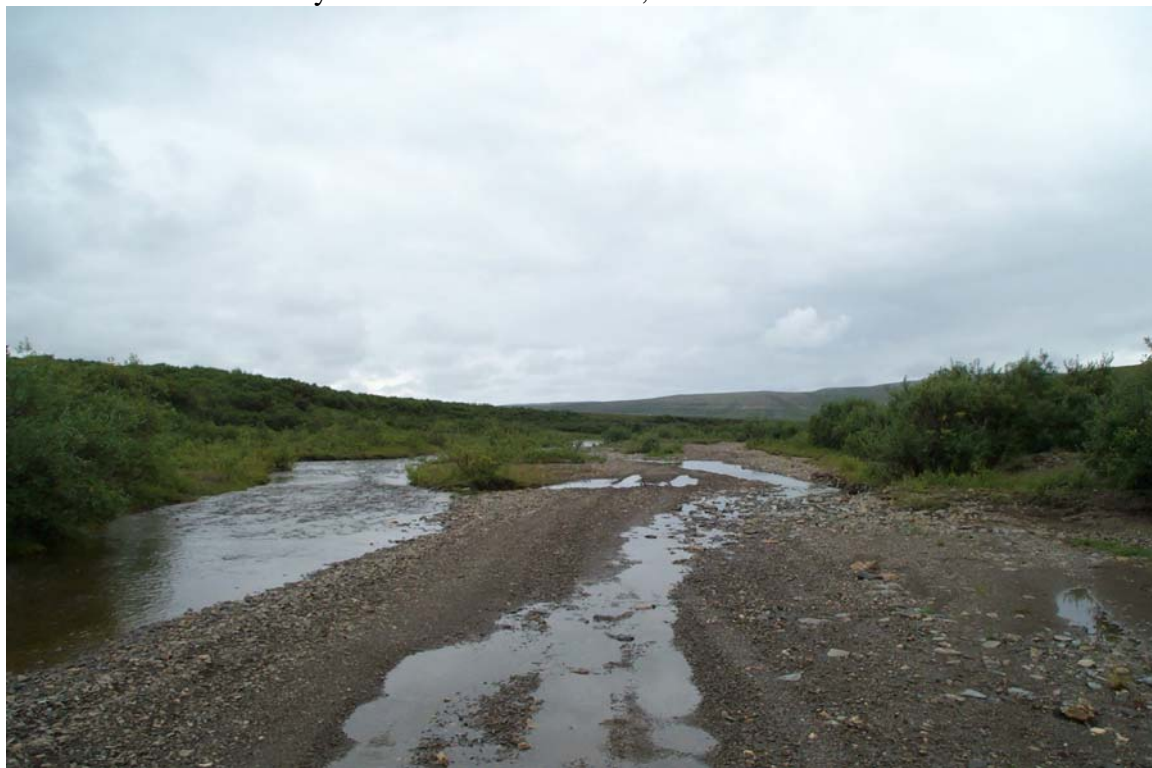
Photo 26. View of disturbed over-widened channel Buster Creek Reach Bu2.

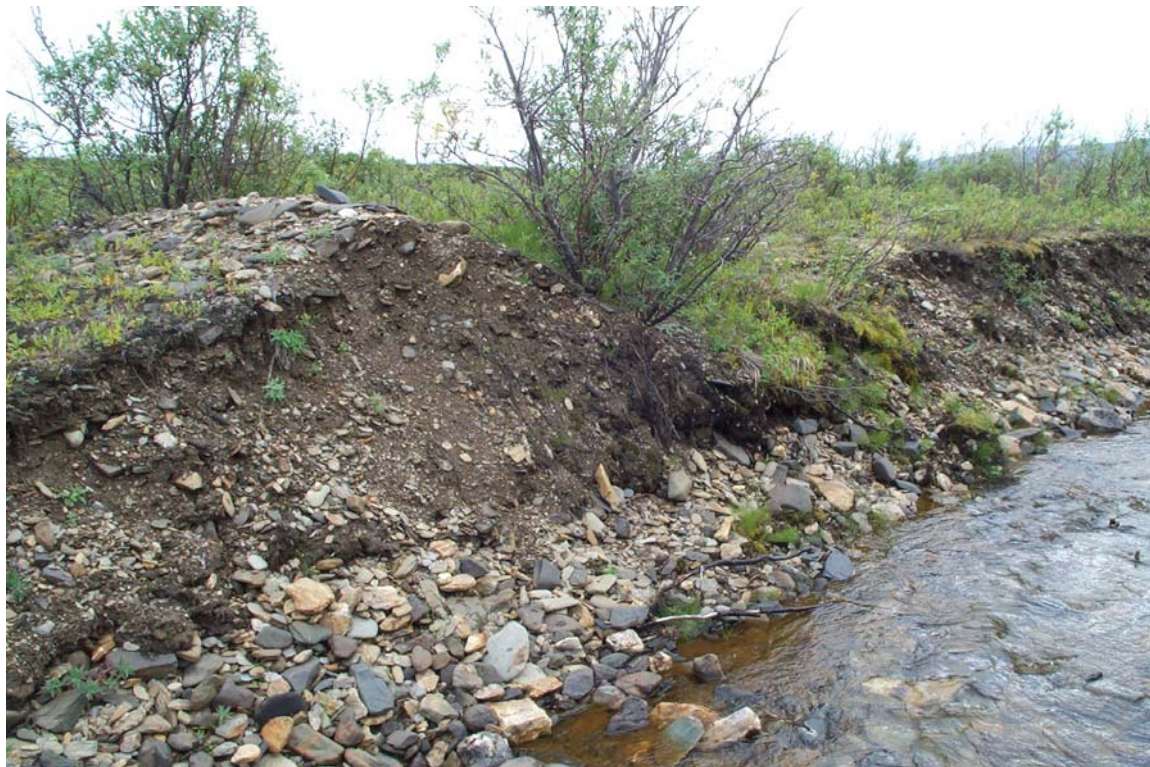
Photo 27. Downstream view of stream eroded tailings pile and bank erosion in Reach Bu3-LF, Buster Creek.

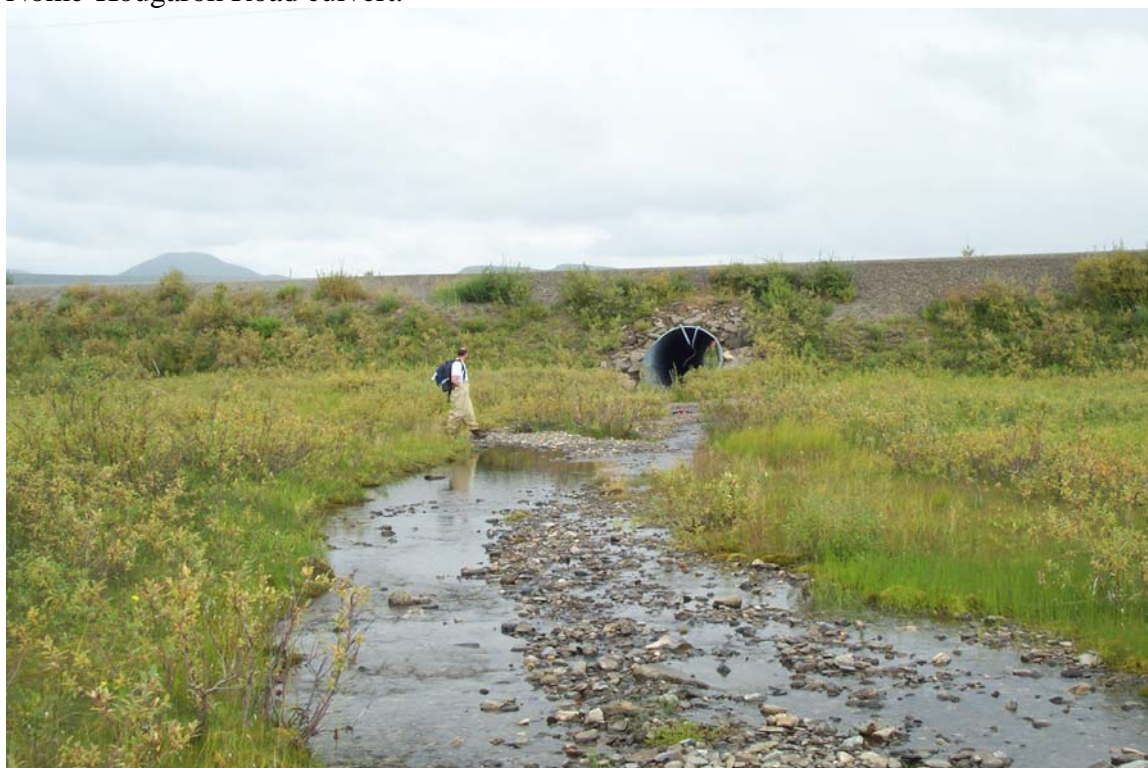
Photo 30. Downstream view of a very disturbed channel in Dexter Creek upstream of culvert in Nome-Kougarok Road.

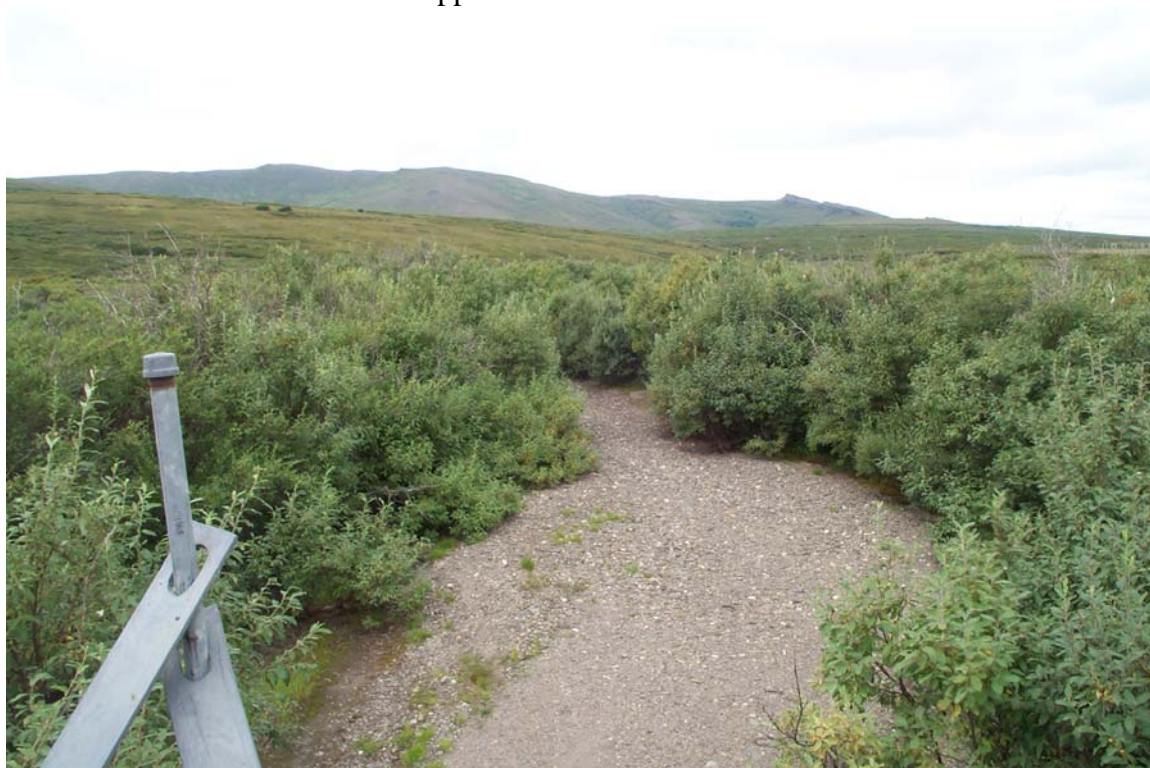
Photo 32. Downstream view of aggraded channel in Banner Creek.

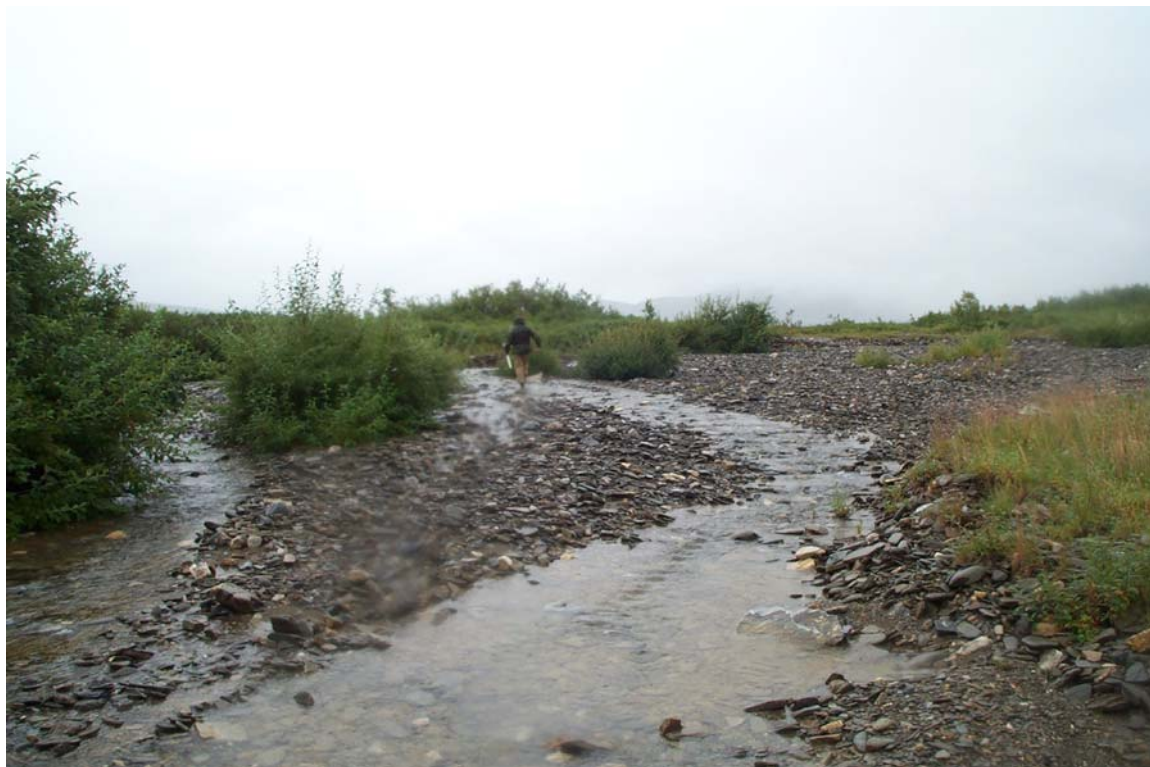
Photo 35. Upstream view at aggraded, over-widened channel in lower Basin Creek.

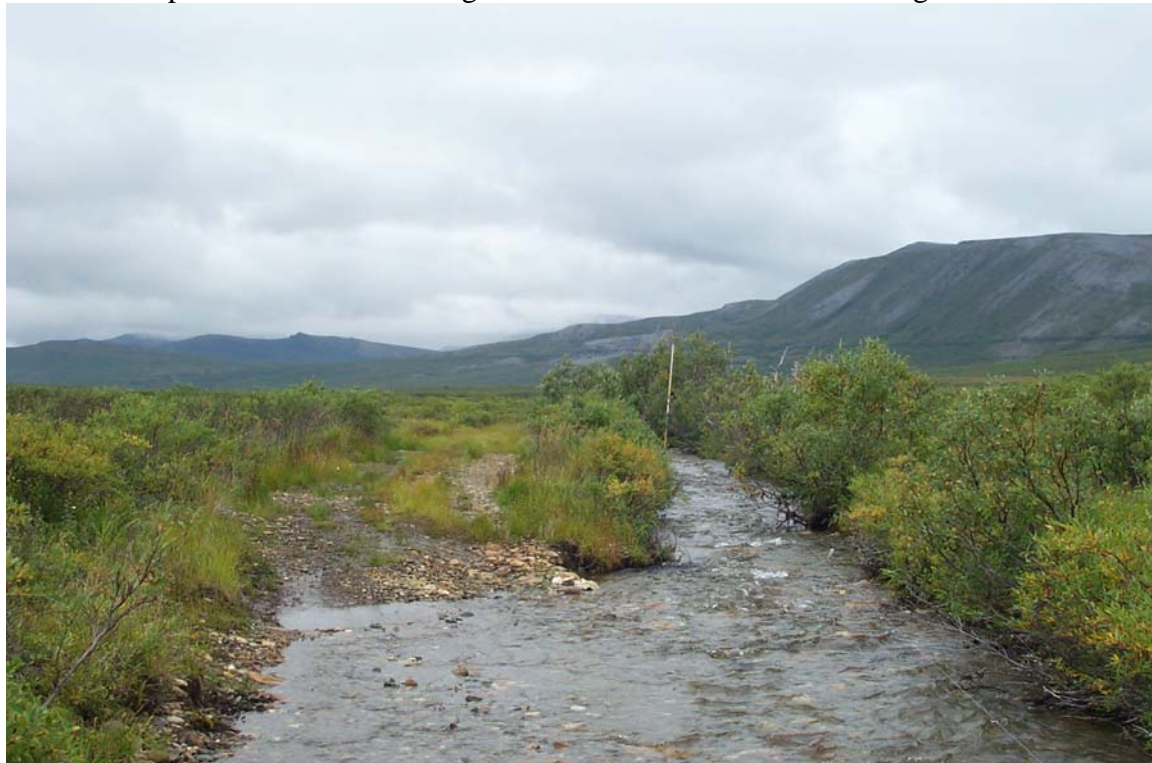
Photo 44. Downstream view showing instream vehicle trail in Darling Creek.

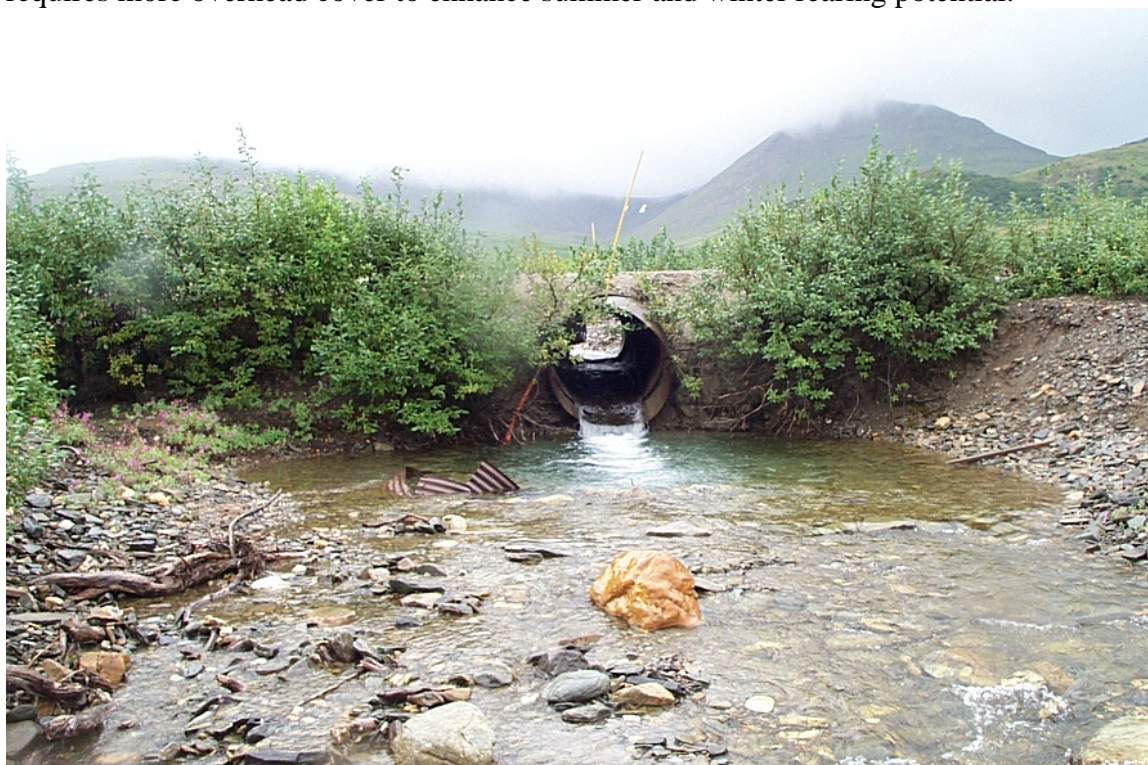
Photo 50. Upstream view of perched culvert (0.30 m drop) at Christian Creek.

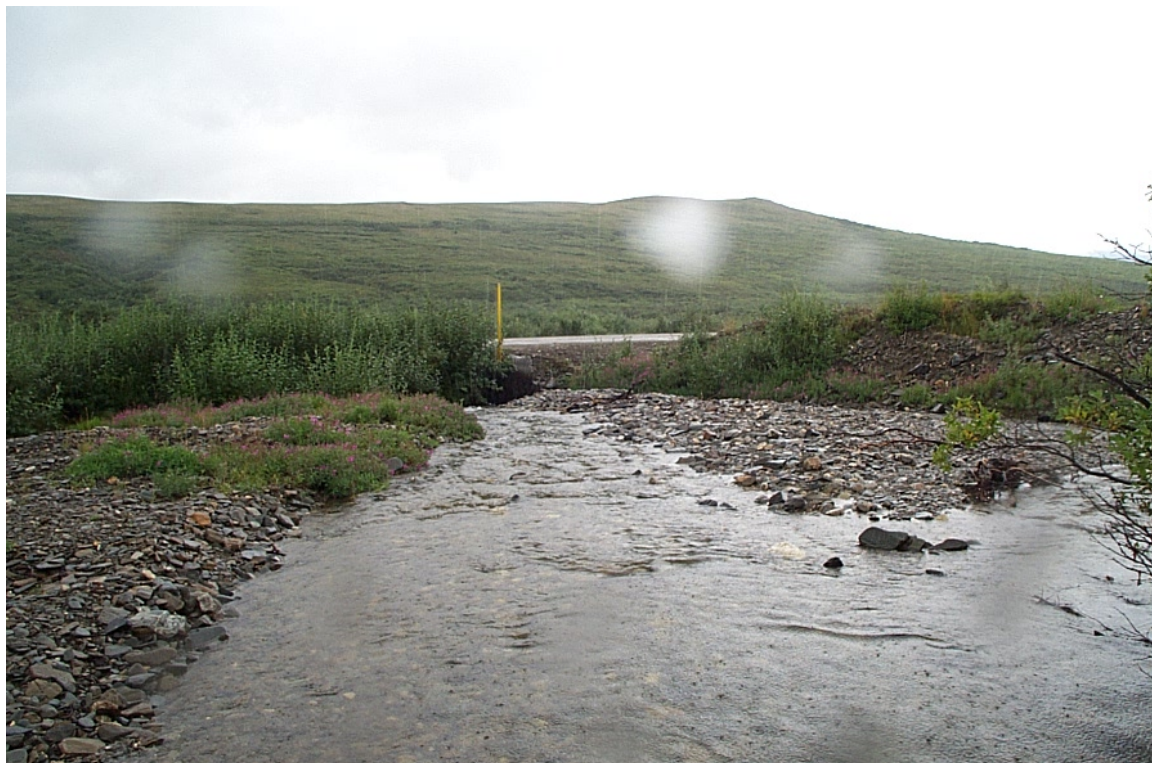
Photo 51. Downstream view of undersized culvert at Christian Creek.
