**DEVELOPMENT AND APPLICATION
OF A SALMON HABITAT RESTORATION FRAMEWORK
ON THE
NOME RIVER WATERSHED, ALASKA**

June 2005

**M.N. Gaboury, R.B. Murray and R.C. Bocking
LGL Limited
environmental research associates
9768 Second Street
Sidney, BC V8L 3Y8**

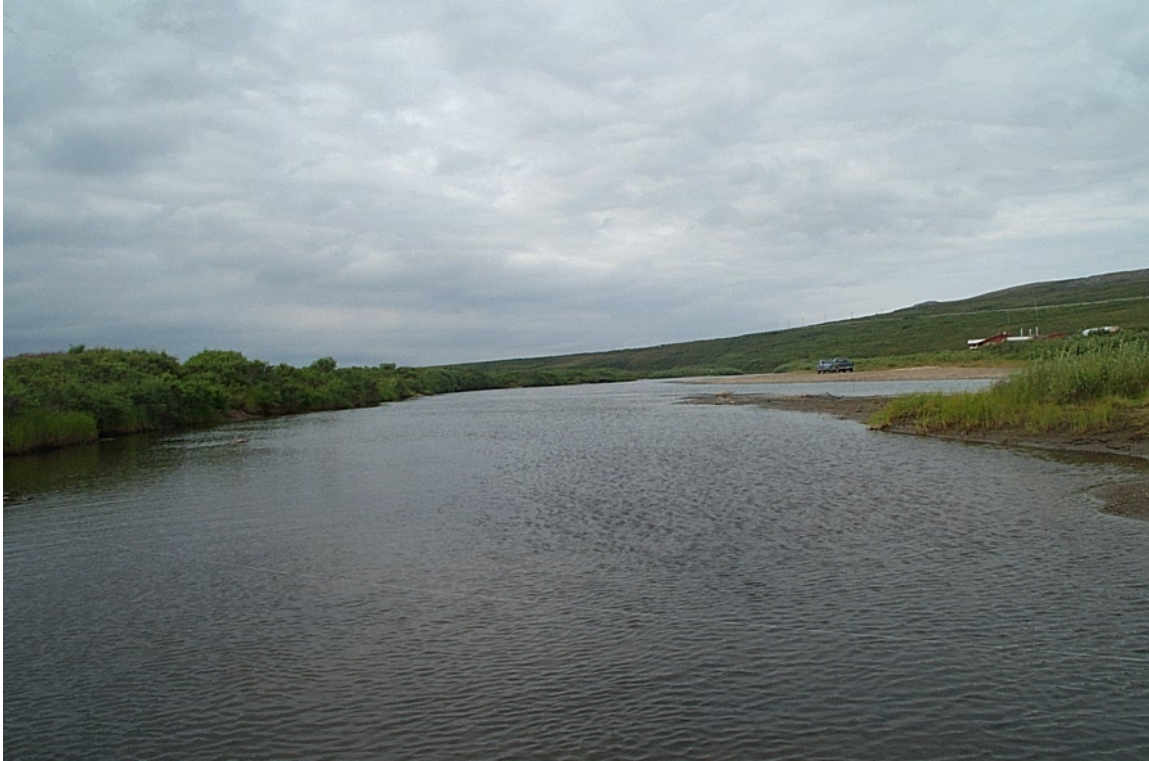
Photo 6. Downstream view in Nome River Reach N1 from confluence of Hazel Creek.

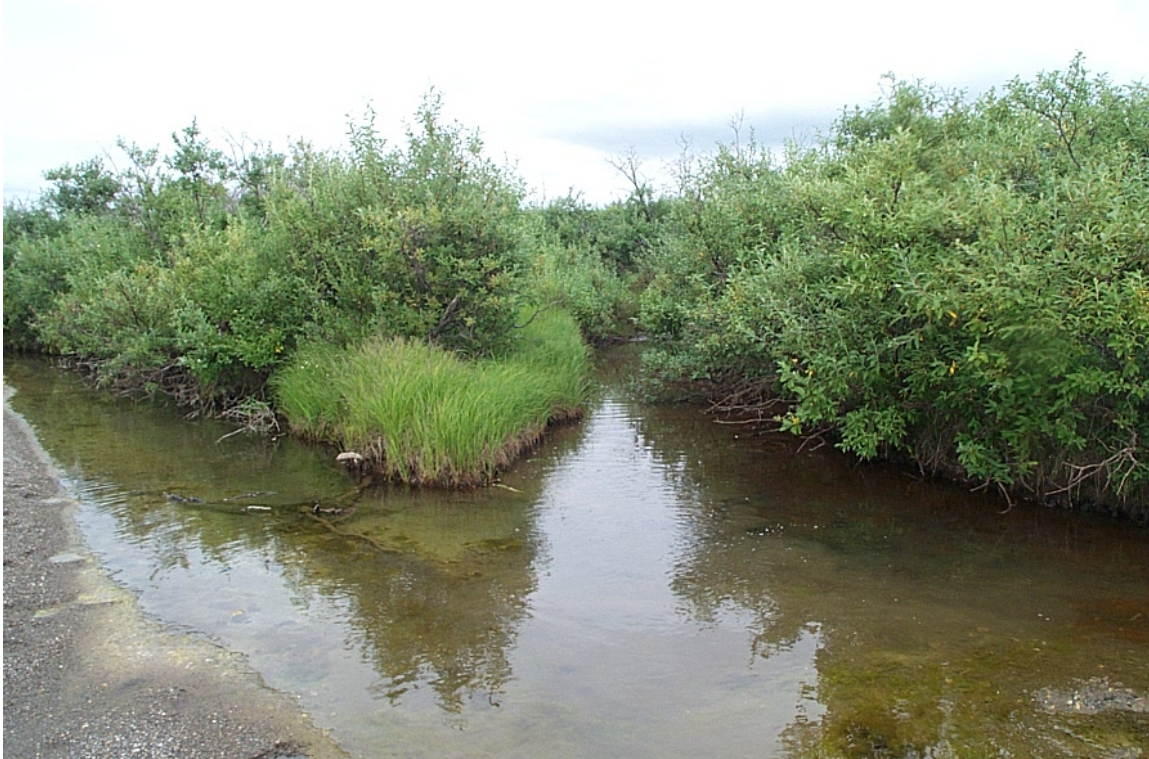
Photo 7. View of excellent summer rearing habitat with overhead riparian cover in off-channel to Reach N1.

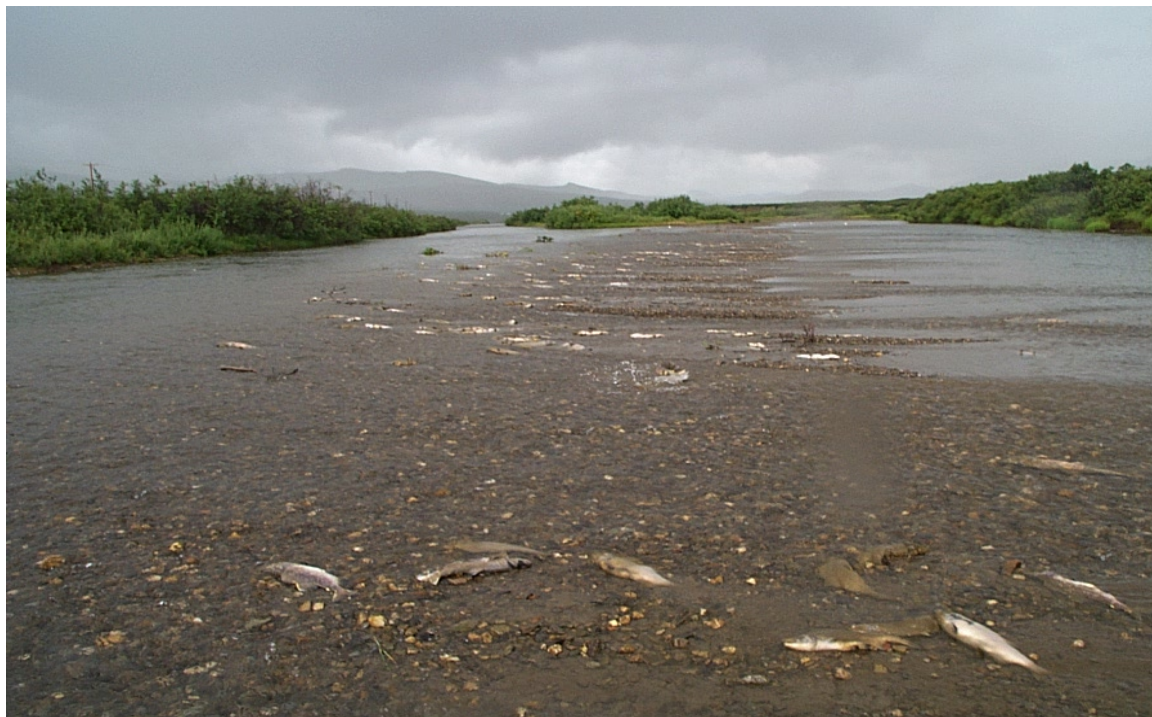
Photo 8. Riffle with spawned-out pink and chum salmon in Reach N2, 28 July 2005.

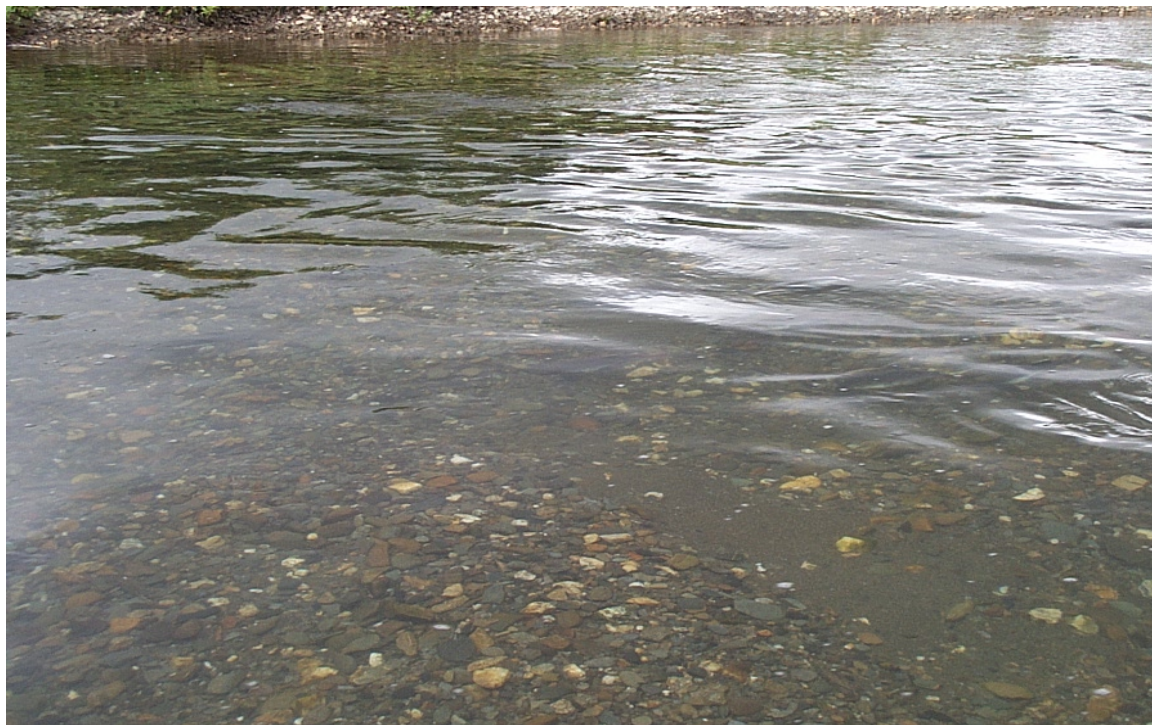
Photo 10. View of multiple redds and clean gravel along left side of Nome channel in Reach N2.

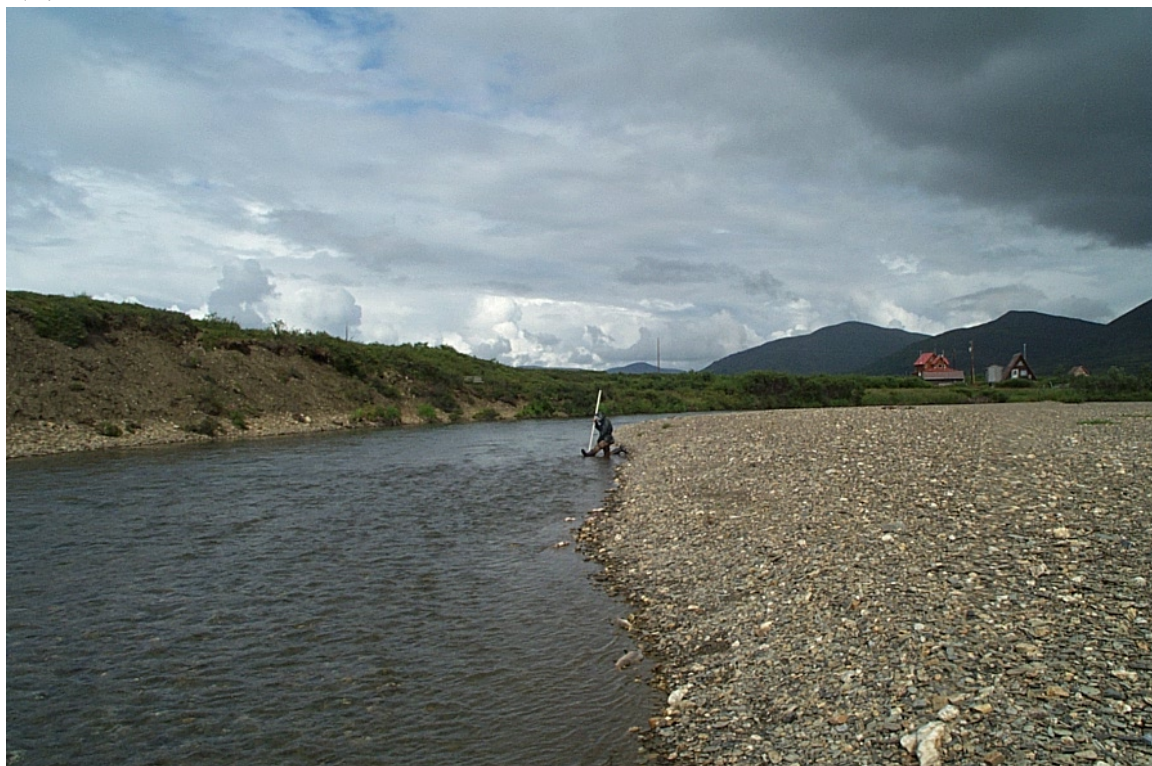
Photo 11. Upstream view in Reach N3 at Banner Creek subdivision in background.

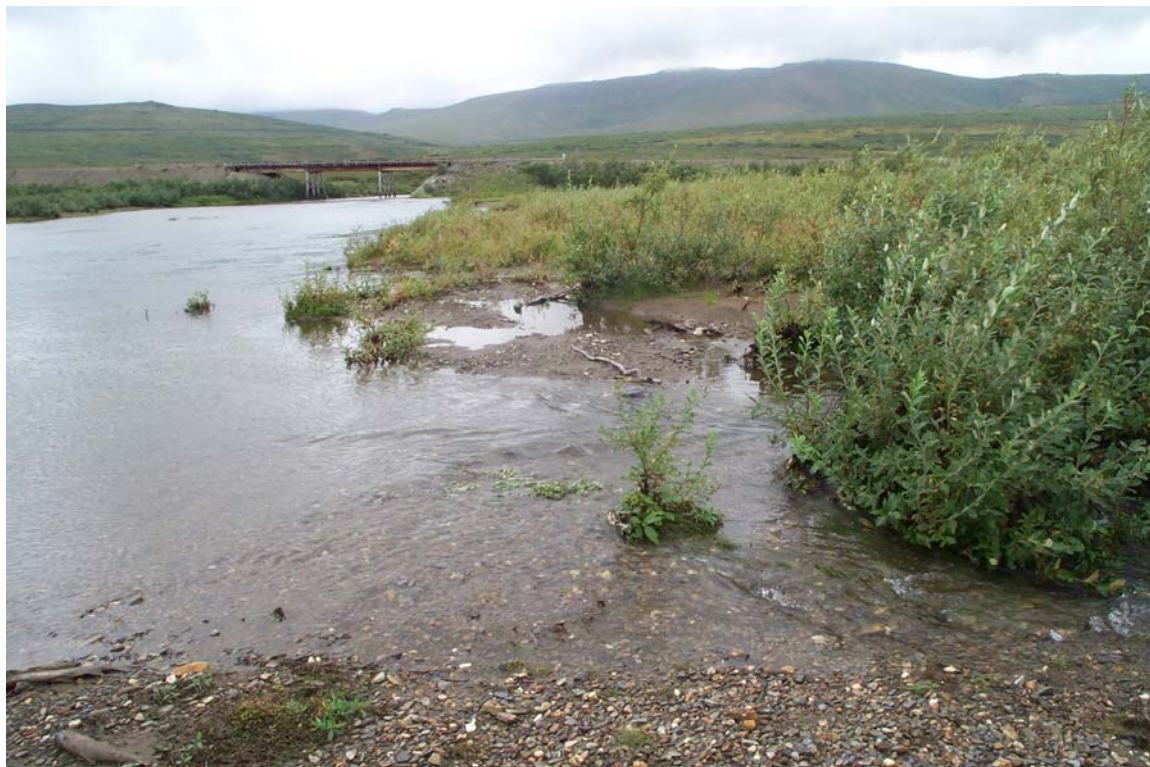
Photo 10. Upstream view in Reach N3 with 13 mile bridge in background.

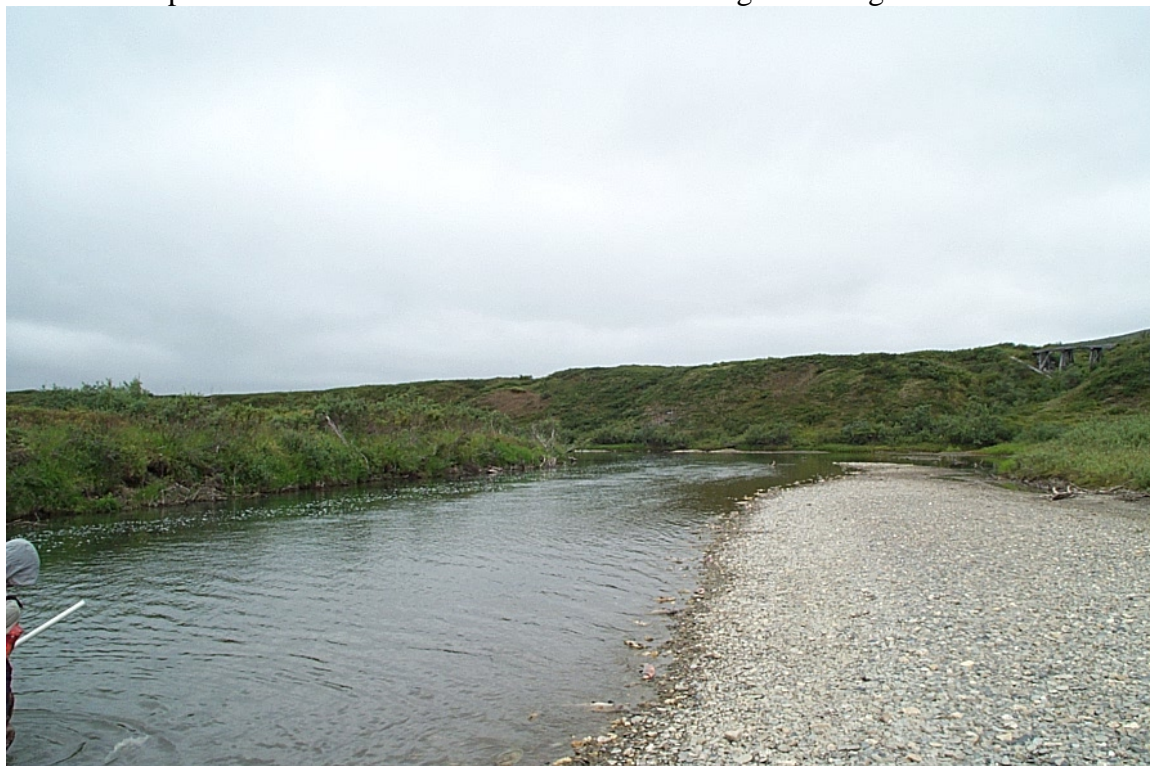
Photo 12. Downstream view in Reach N4. Old railway trestle in photo right background.

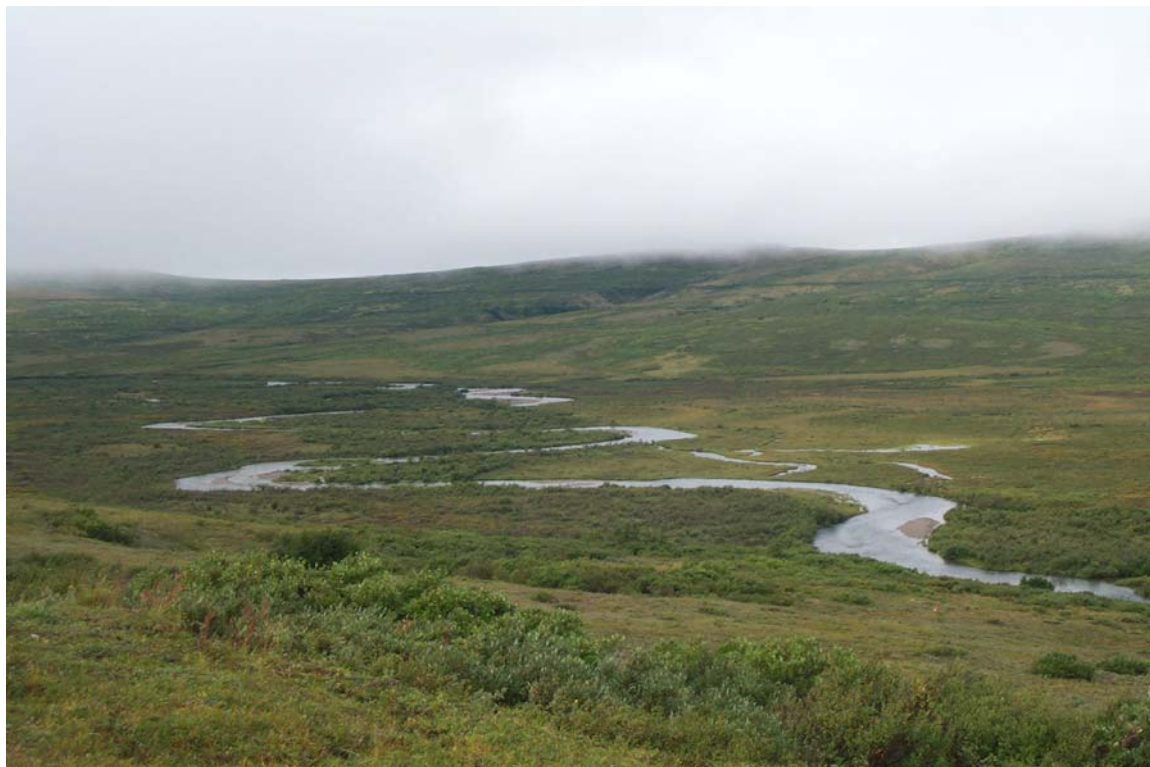
Photo 13. Downstream view of unconfined meander pattern and off-channel habitat in Reach N5.

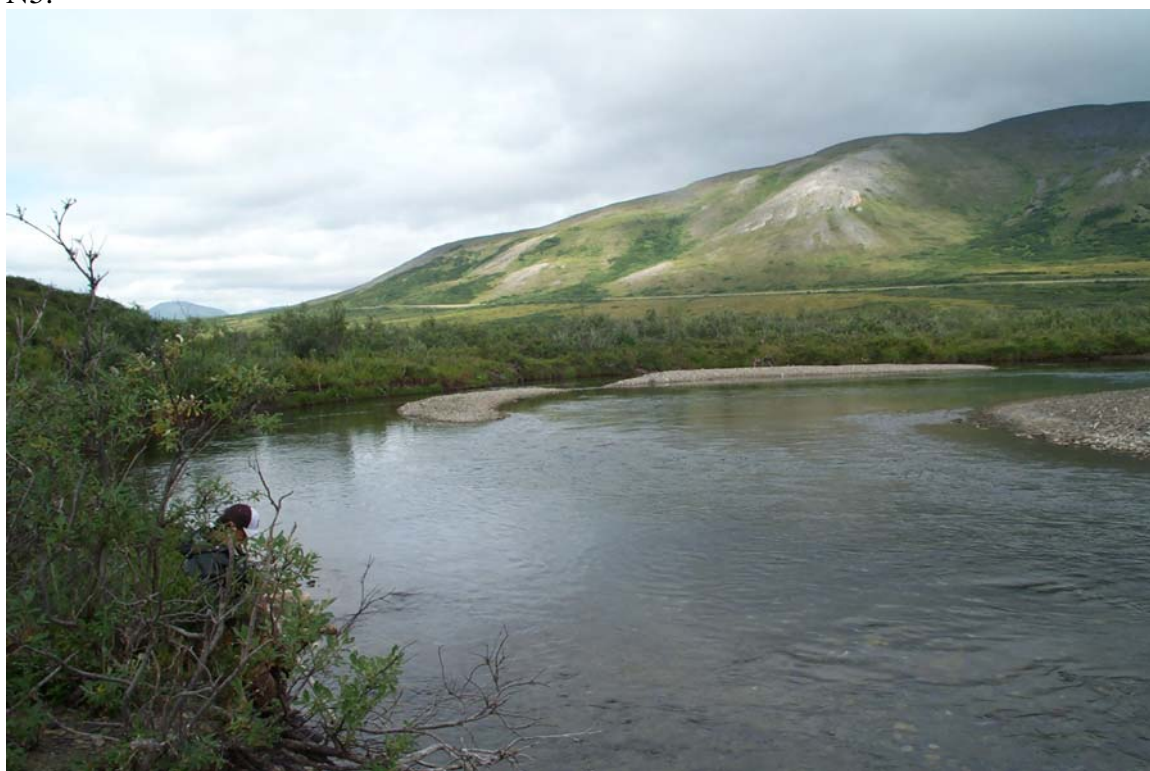
Photo 14. Upstream view of typical deep meander bend pool in Reach N5.

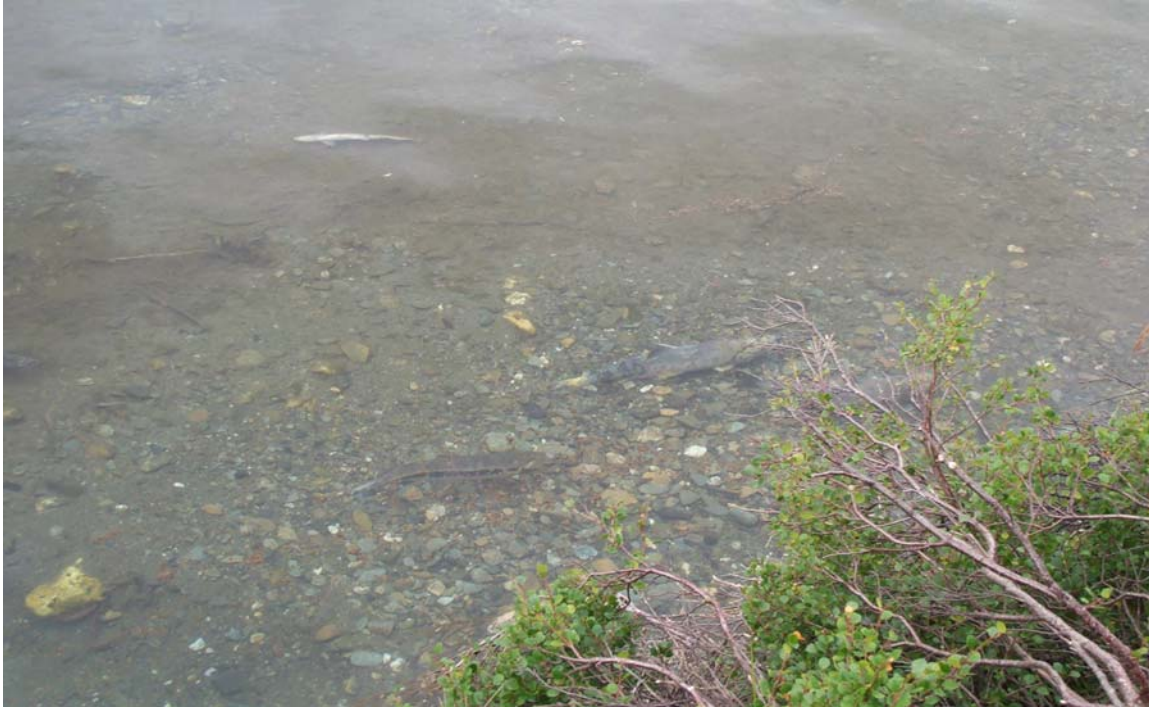
Photo 15. View of chum salmon actively spawning in typical site close to overhanging vegetation escape cover in 0.6 - 0.8 m stream depth and velocity 0.5 – 0.7 m/s.

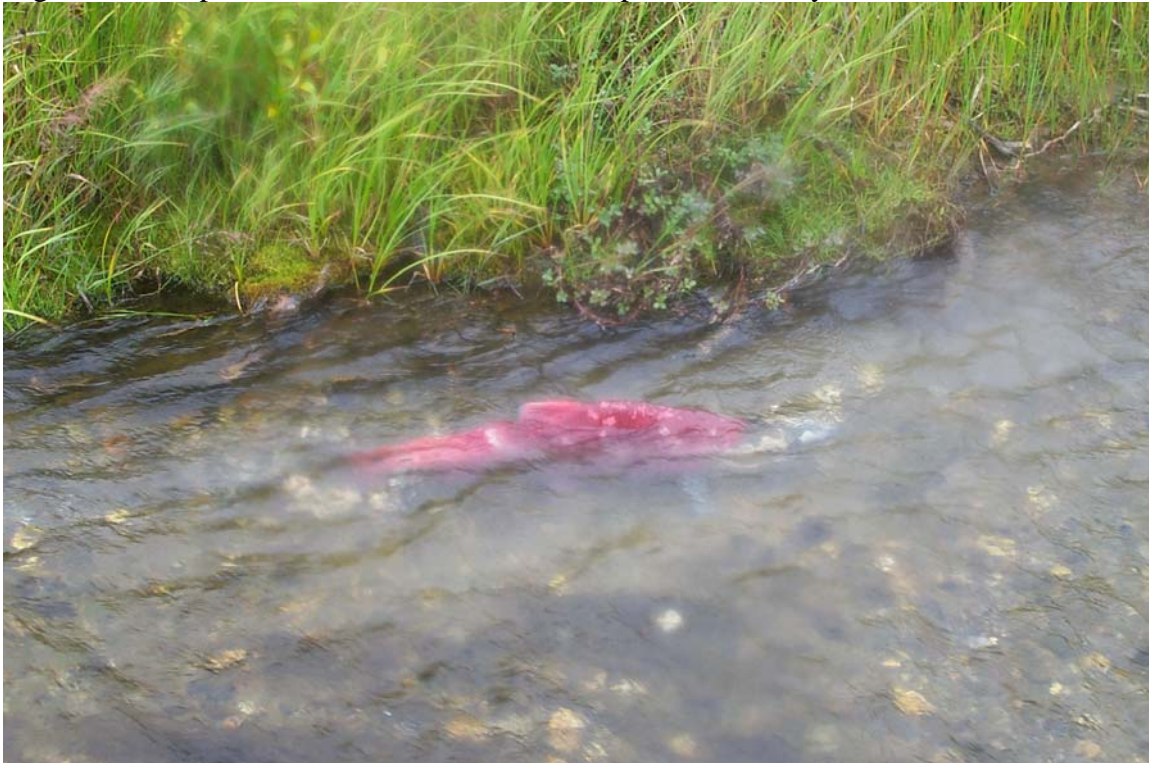
Photo 16. View of sockeye in off-channel in Reach N5.

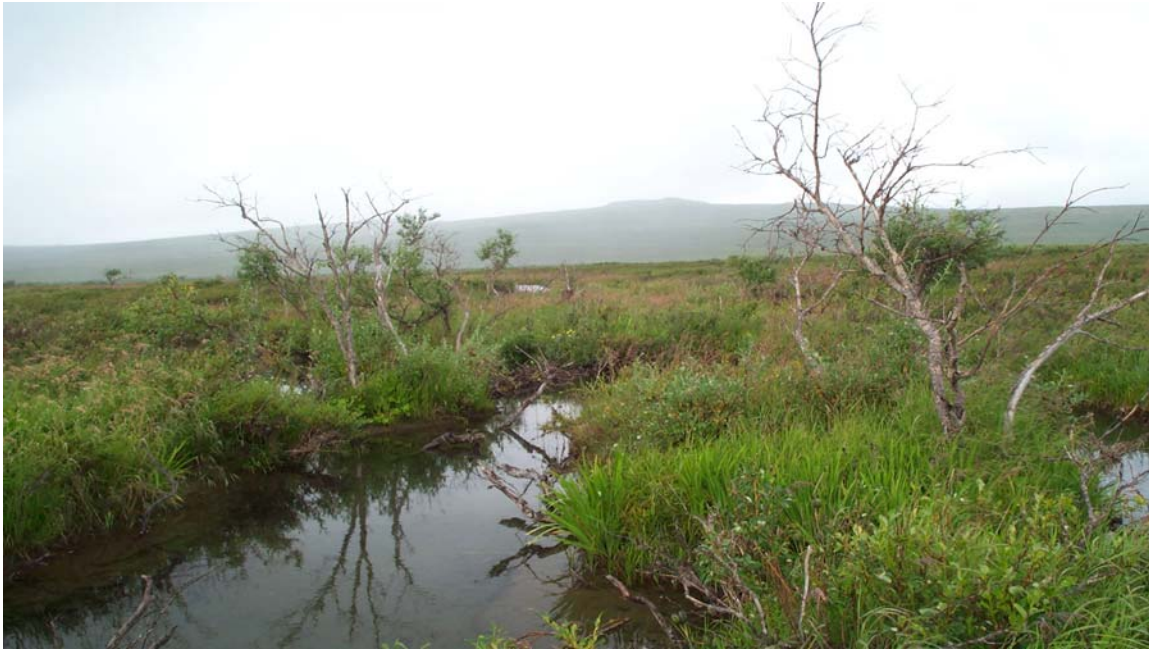
Photo 17. View of off-channel habitat in Reach N5 with excellent cover for summer rearing coho.

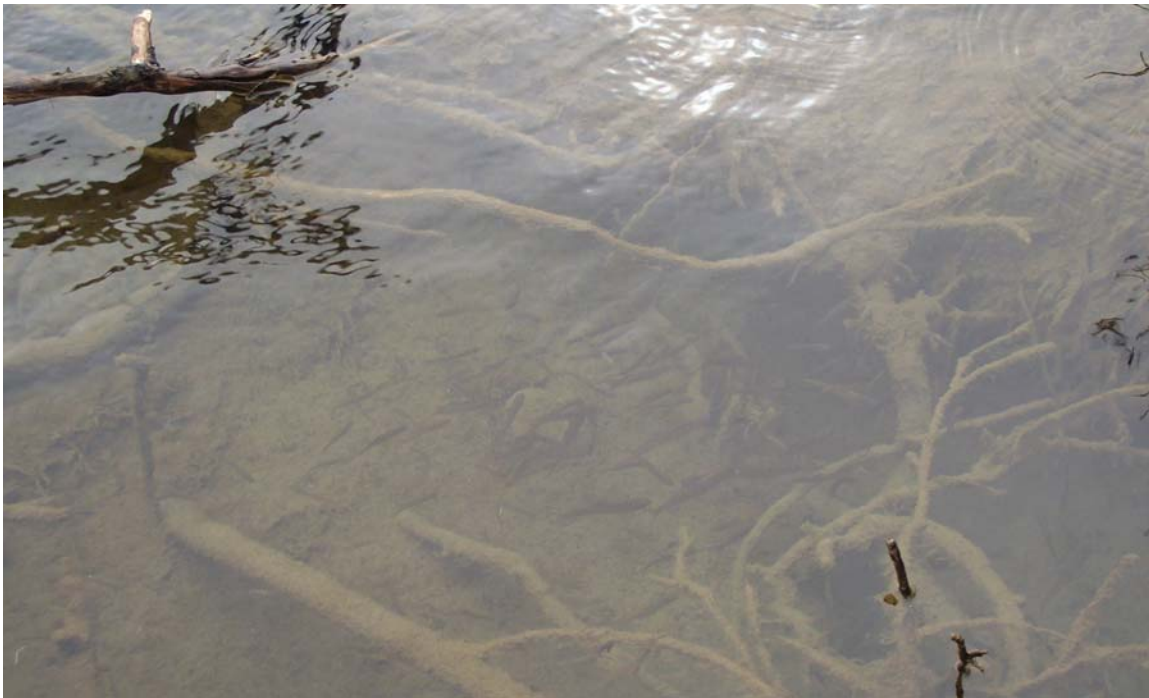
Photo 18. View of juvenile coho age class 0+ and 1+ utilizing SWD, undercut bank cover, and overhanging vegetation cover in off-channel in Reach N5.

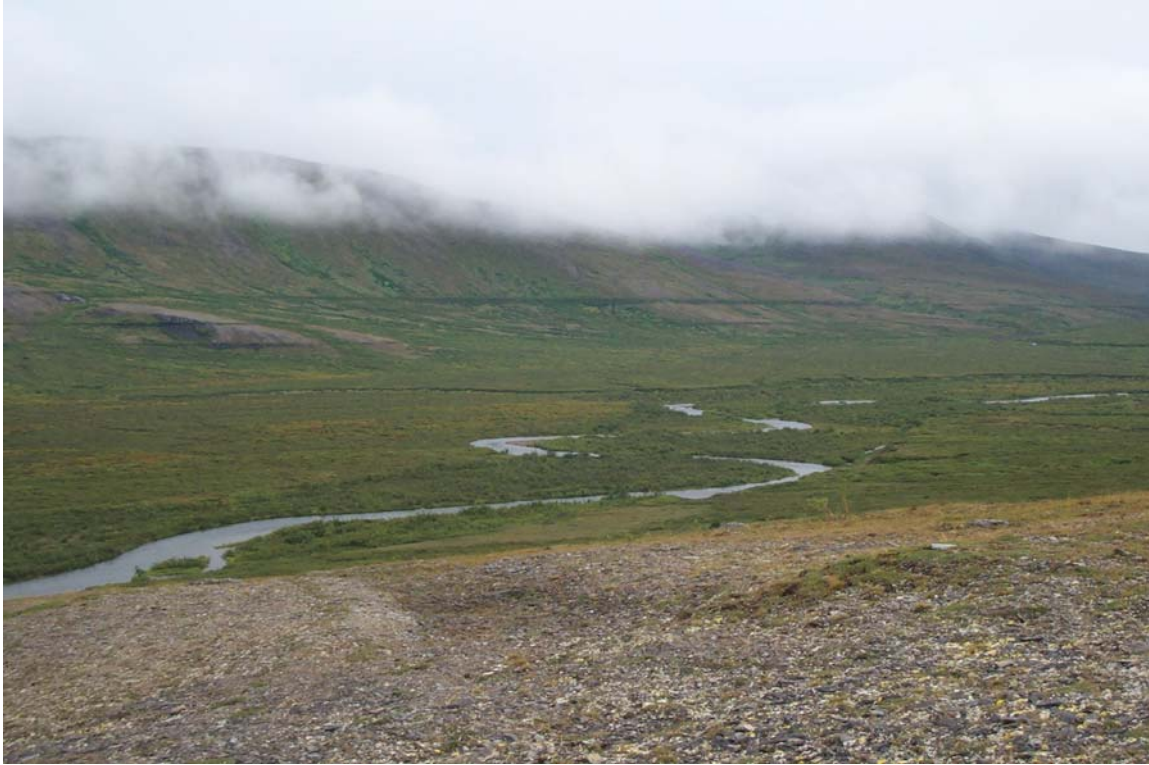
Photo 19. Upstream view of Nome mainstem Reach N6 from Nome-Kougarok Road.

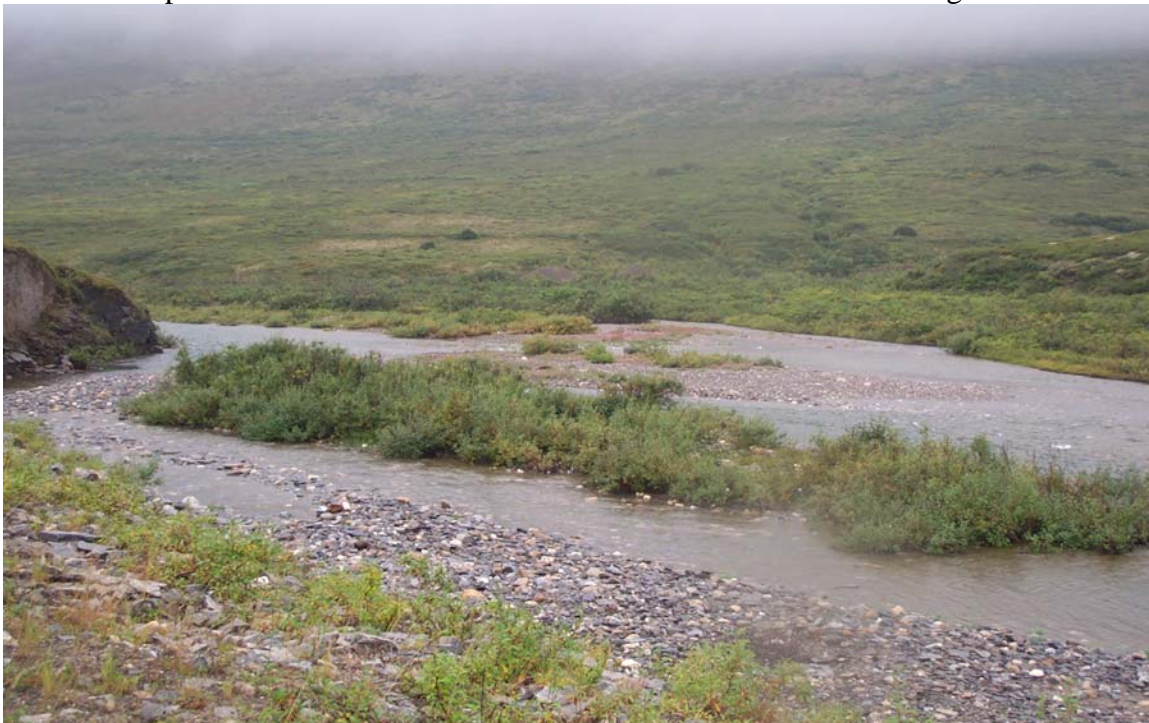
Photo 20. Downstream view of Nome River Reach N7 from chainage 50+090 m illustrating aggraded channel with mid-channel bars and multiple channels (indicators of channel disturbance).

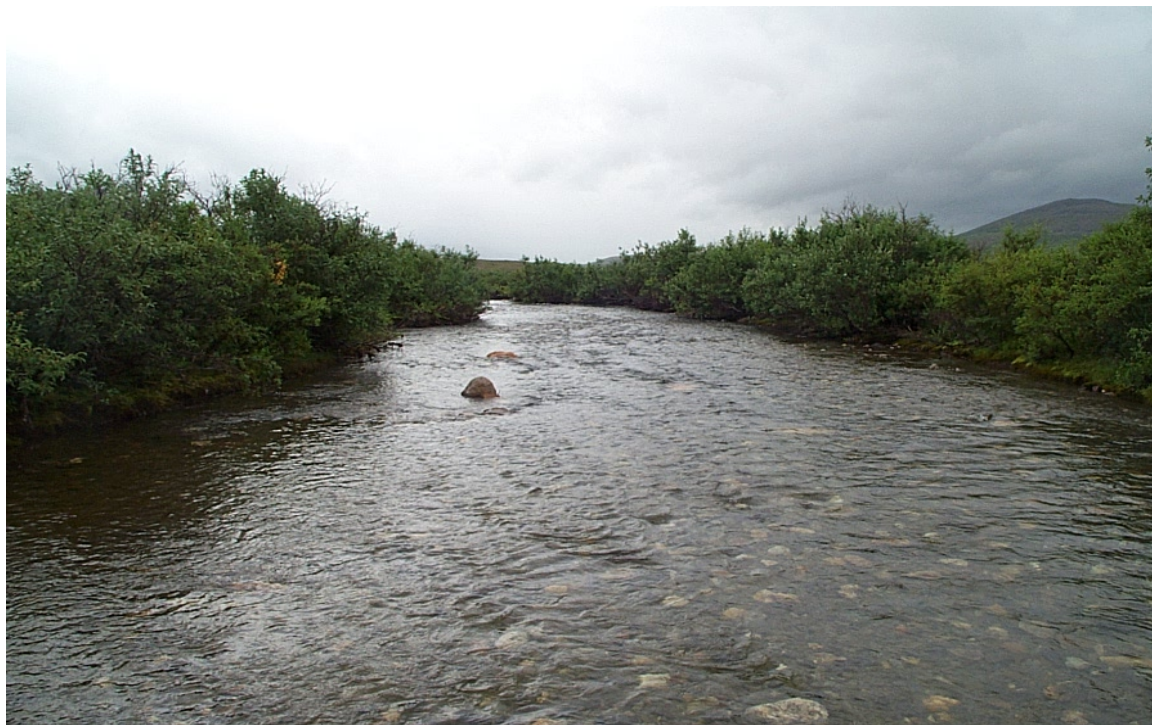
Photo 21. Downstream view in Reach N8 at chainage 60+502 m.

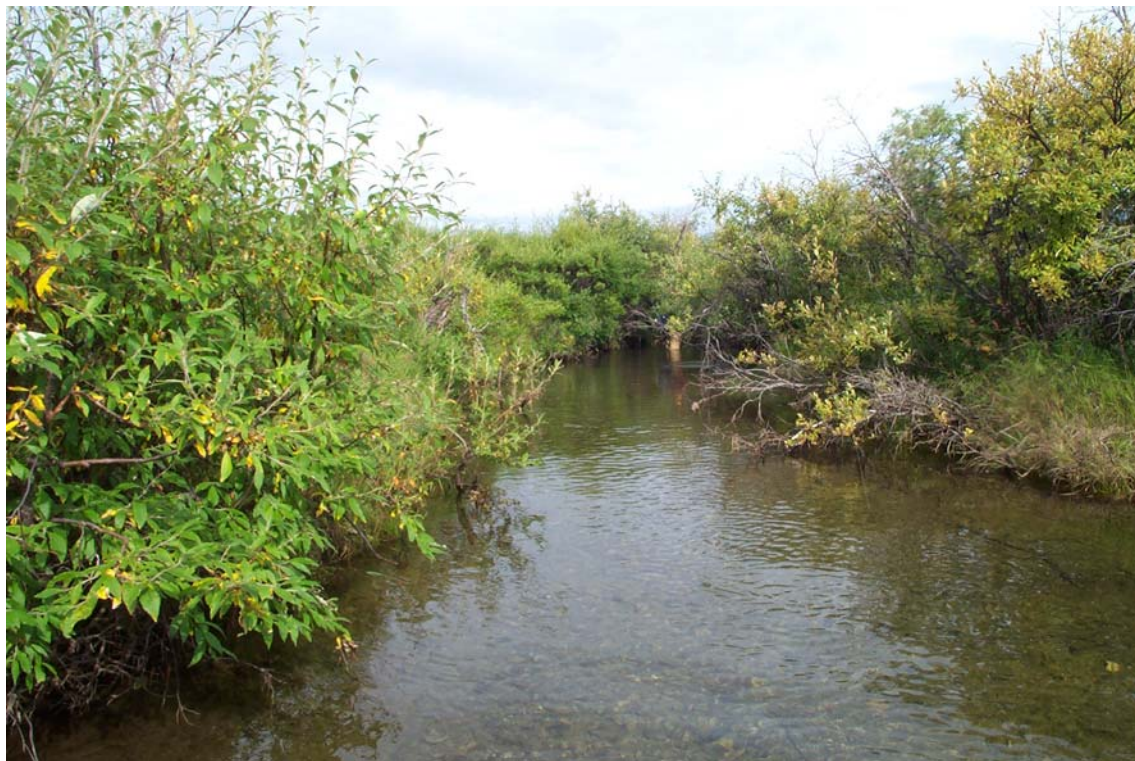
Photo 23. Upstream view in Buster Creek Reach Bu1 illustrating good summer rearing habitat with cover provided by overhanging vegetation, undercut bank and SWD.

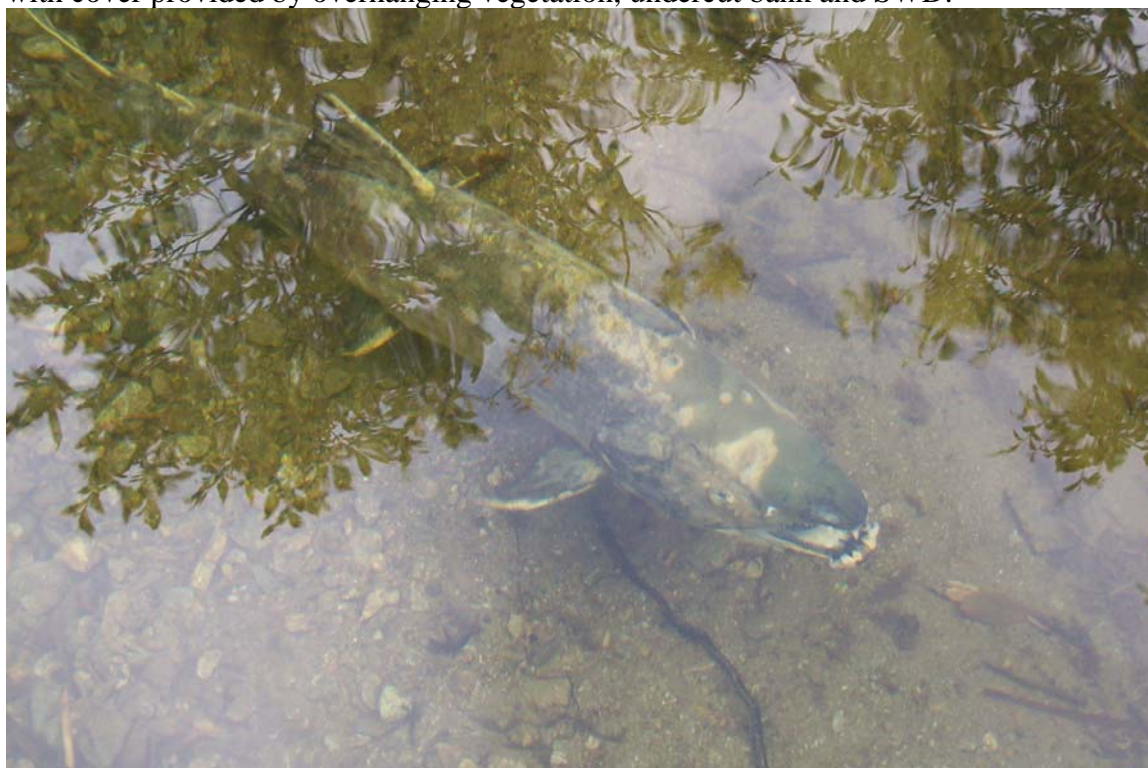
Photo 24. View of spawned out chum in shaded pool in Buster Creek, Reach Bu1.

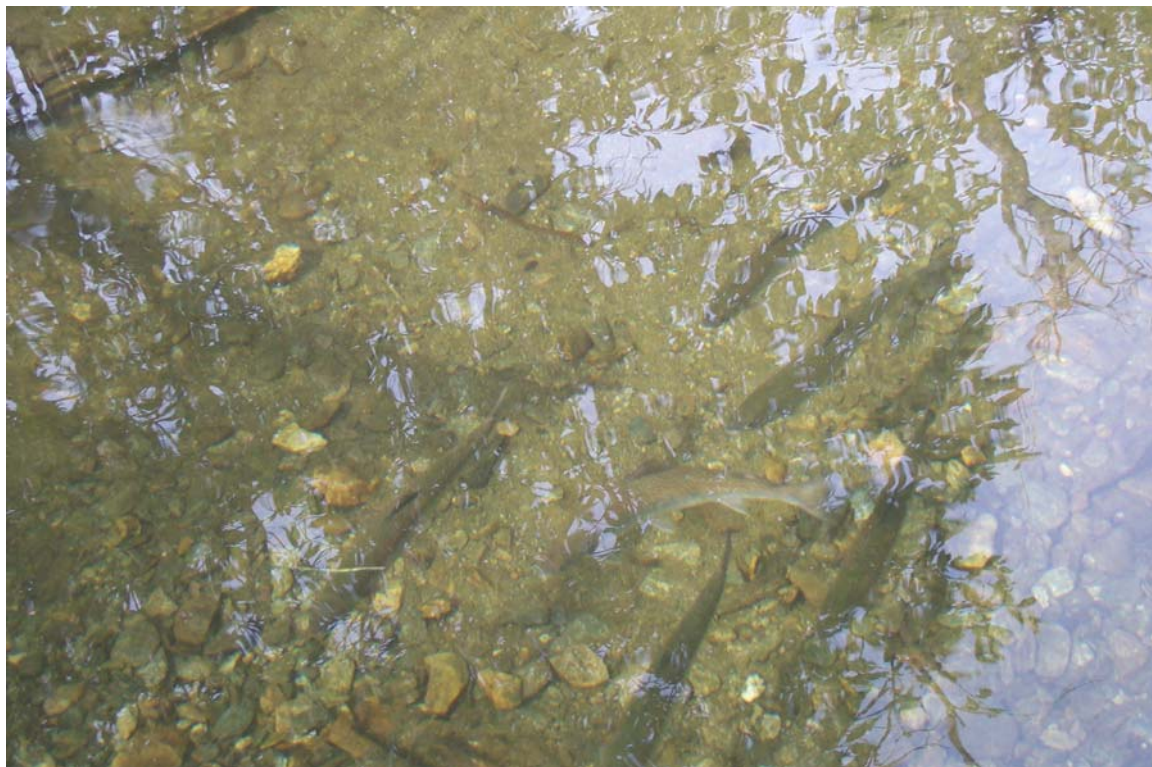
Photo 25. View of Dolly Varden in Buster Creek, Reach Bu1.

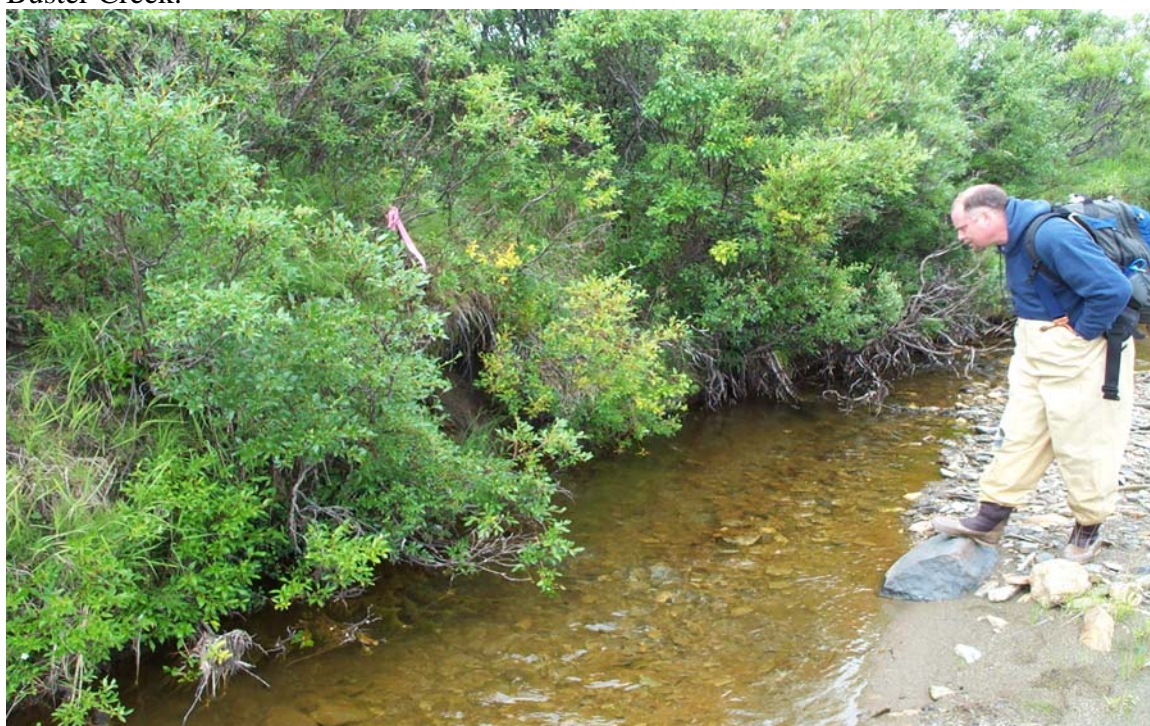
Photo 28. Upstream view of good summer rearing habitat for juvenile coho, Reach Bu3-LF, Buster Creek.

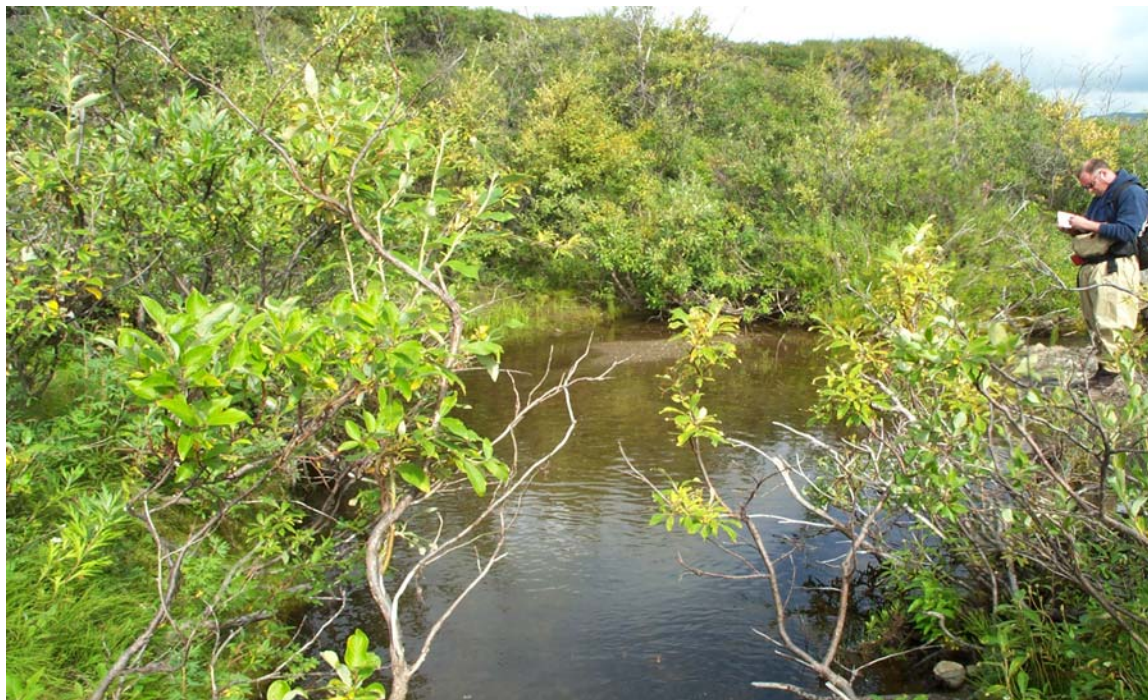
Photo 29. Downstream view of rearing pool with cover in Dexter Creek (Dx-1), downstream of Nome-Kougarok Road culvert.

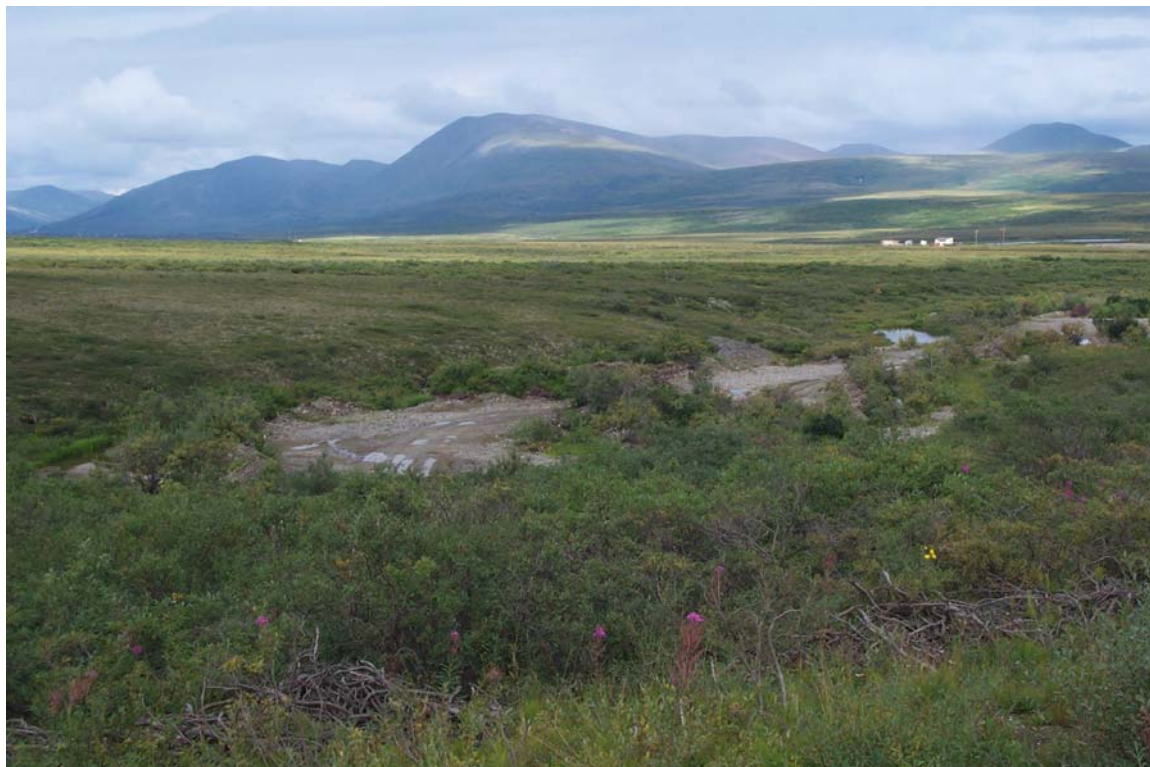
Photo 31. Downstream view of upper Dexter Creek.

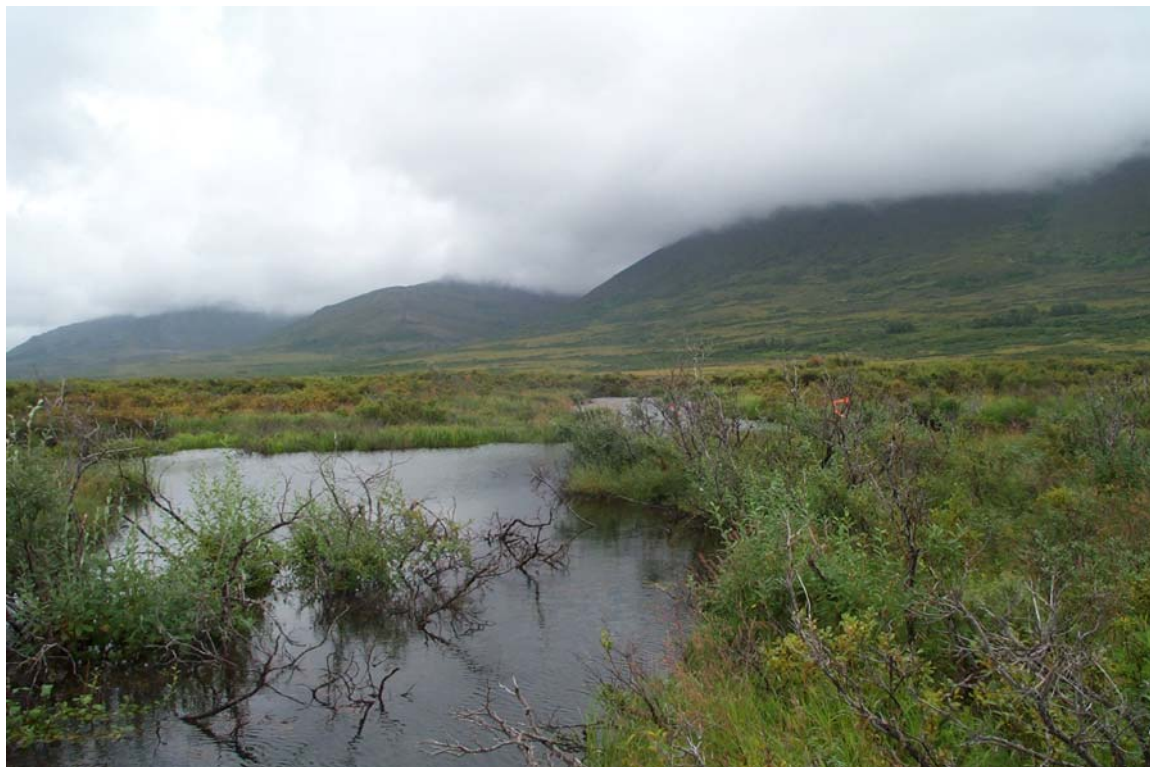
Photo 33. View of Mineral Creek off-channel complex from Nome-Kougarok Road.

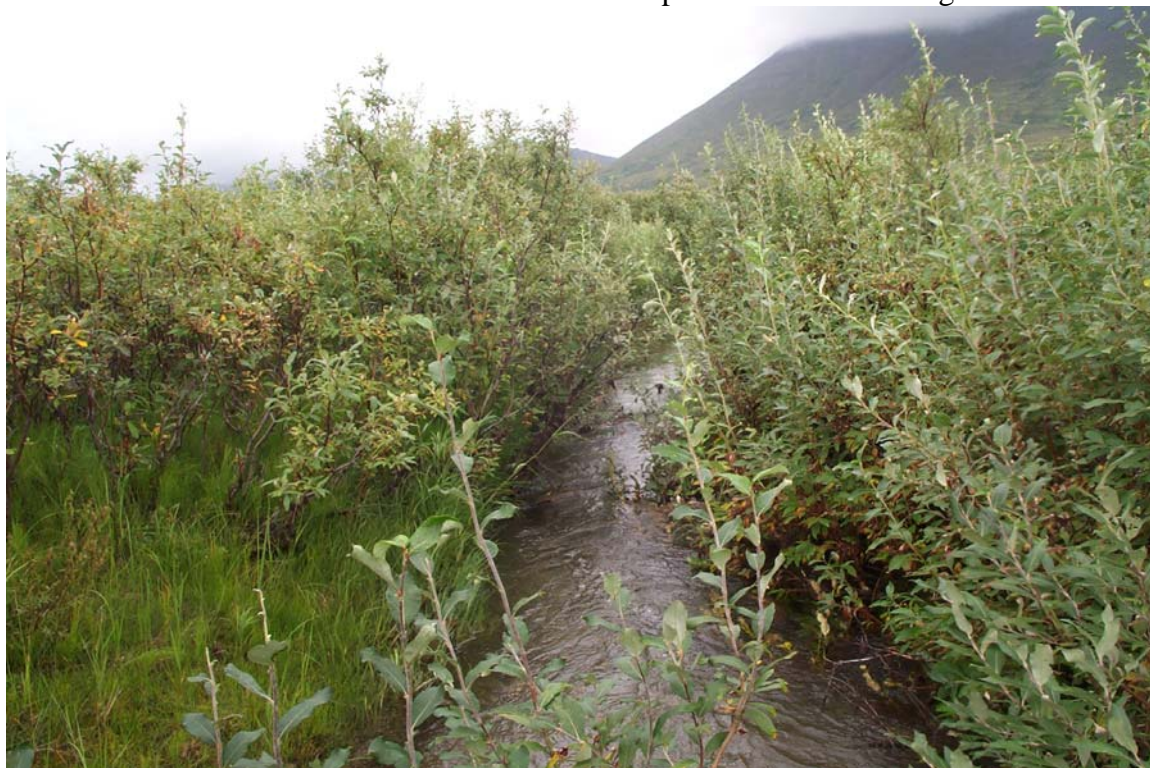
Photo 34. View of channel from Nome River connecting Mineral Creek off-channel complex downstream of 13 mile bridge.

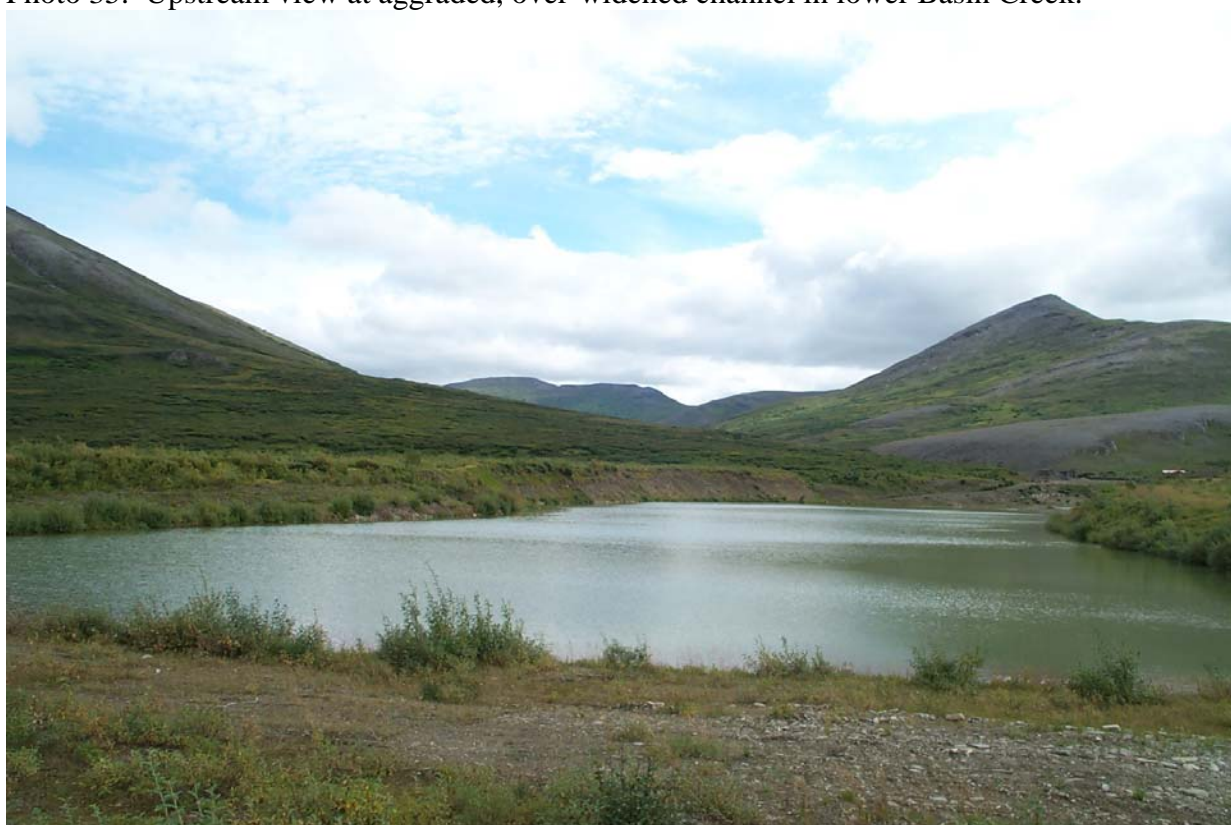
Photo 36. View from west bank of Basin Creek instream pond.

Overhead and in-channel cover is very limited in Basin Creek Pond currently. Increasing the amount of cover in the pond would improve the quality of rearing habitat. To increase the amount of cover, it is proposed that LWD structures be added to the west side of the pond and willows planted. Up to 14 LWD structures will be located every 20 m along the west bank (Photo 36). Structure configuration will be similar to a DJ-5 LWD structure (Appendix G). Each proposed LWD structure will be comprised of five logs. It is anticipated that the logs with rootwads will have an average dbh of 0.3 to 0.5 m and be approximately 8 to 12 m long. It is assumed that LWD will be transported from the shoreline near Nome to Basin Creek Pond. LWD cover structures will be fastened to deadman anchors to ensure greater stability for the structures. Deadman anchors will consist of a log without a rootwad about 5-6 m long and 0.3-0.5 m diameter buried 1 to 2 m below the ground surface. Alternatively, large boulders could be used as deadman anchors or the tops of some of the LWD could be buried in the ground (e.g., Appendix G). As described in Section 4.3.3.1, cover structures such as brush bundles, artificial undercut banks and mounds of oversize rock can be used as alternatives to the LWD structures.
