**DEVELOPMENT AND APPLICATION
OF A SALMON HABITAT RESTORATION FRAMEWORK
ON THE
NOME RIVER WATERSHED, ALASKA**

June 2005

**M.N. Gaboury, R.B. Murray and R.C. Bocking
LGL Limited
environmental research associates
9768 Second Street
Sidney, BC V8L 3Y8**

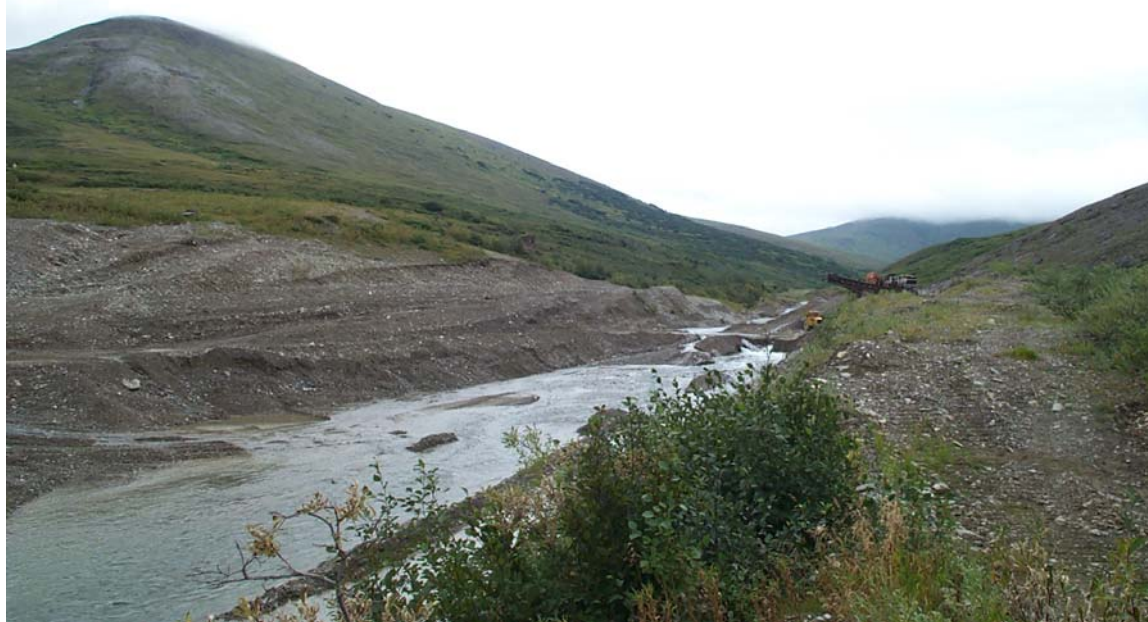
Photo 37. Upstream view at disturbed, over-widened channel in upper Basin Creek. Gravel extraction and placer mining operations are occurring in this reach.

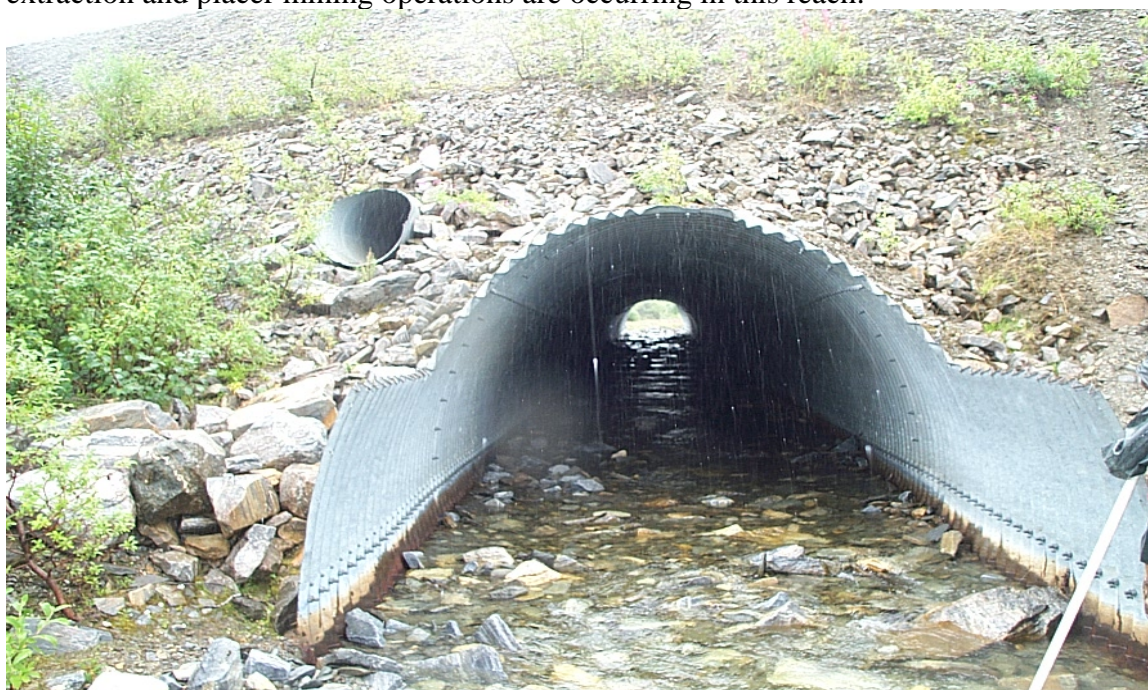
Photo 38. Upstream view of natural substrate in culvert on Sampson Creek. This is a good example of a culvert placement that would provide fish passage.

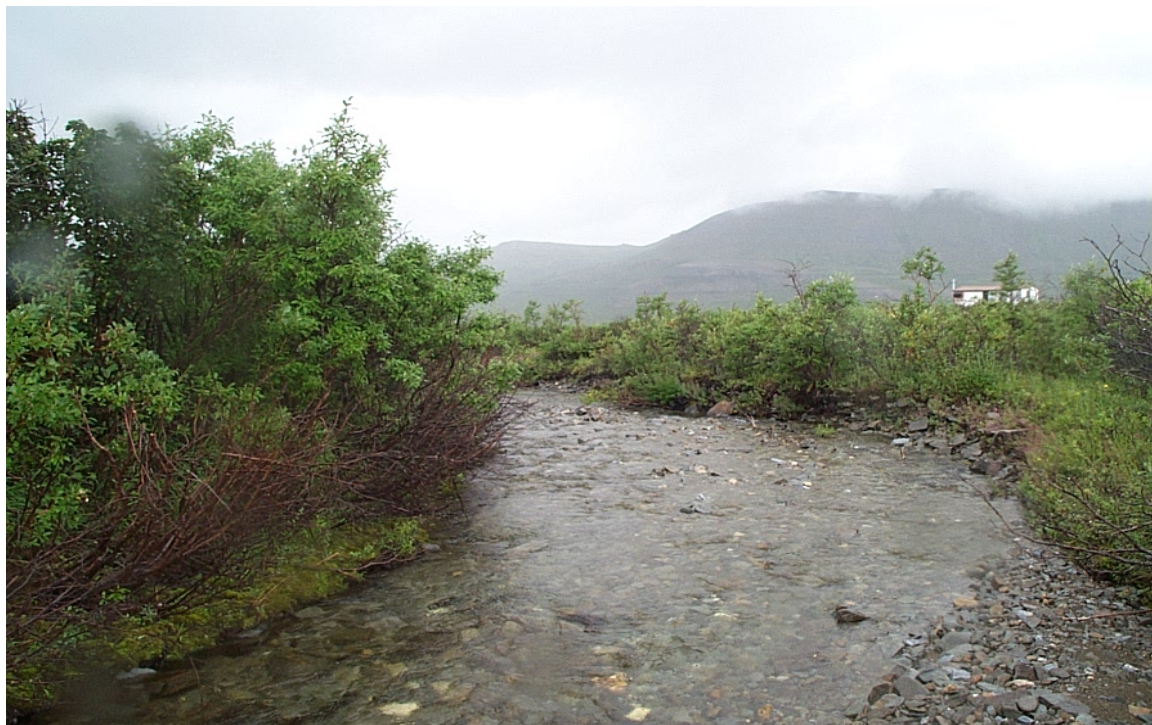
Photo 39. Downstream view of Sampson Creek channel approximately 100 m below culvert.

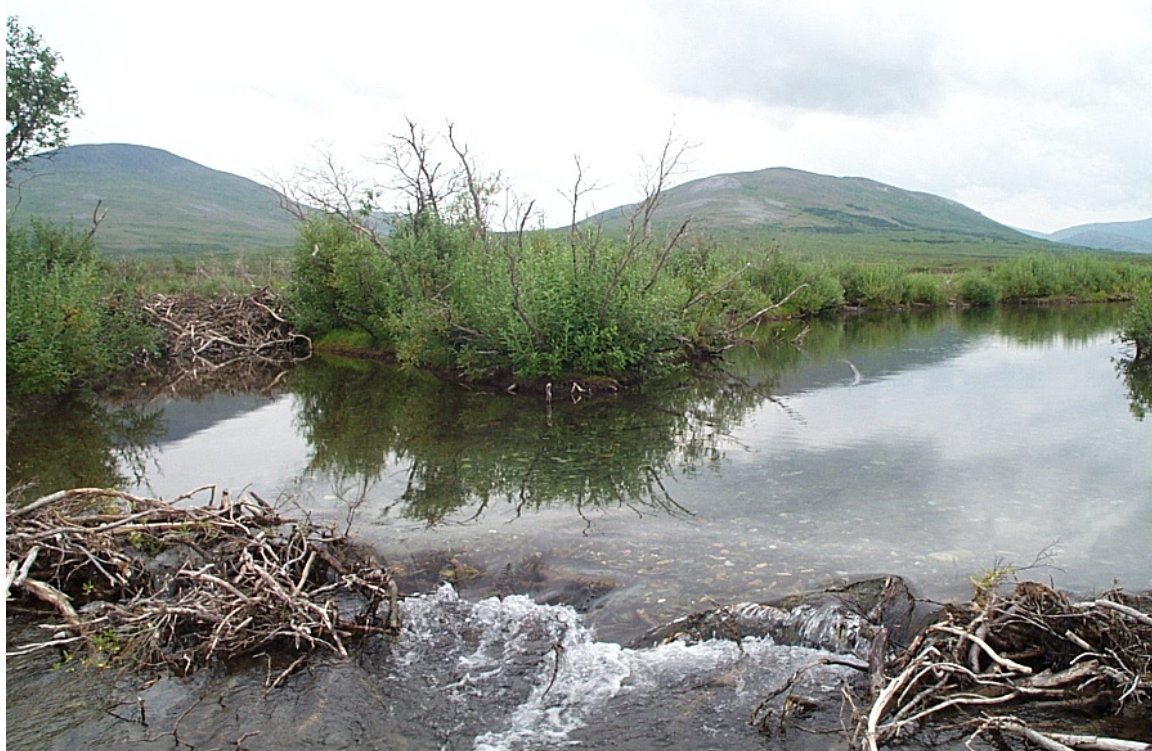
Photo 40. Upstream view of beaver dam on lower Hobson Creek.

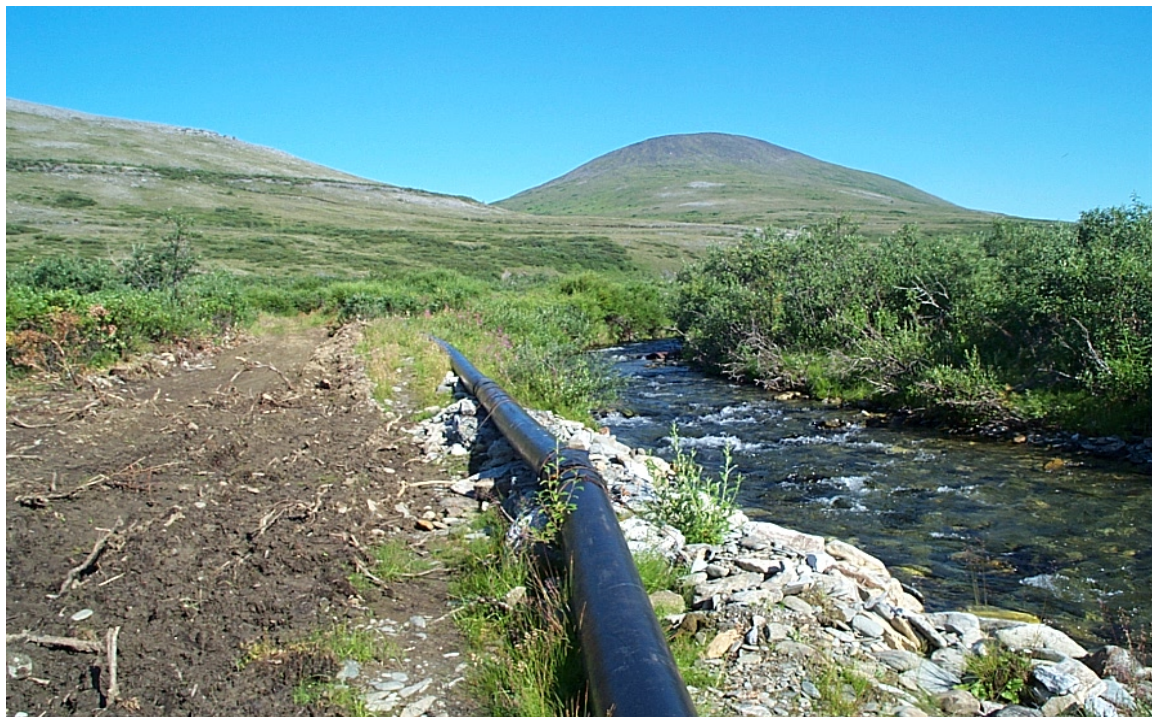
Photo 41. Upstream view of Hobson Creek (Reach H2) and road to hatchery.

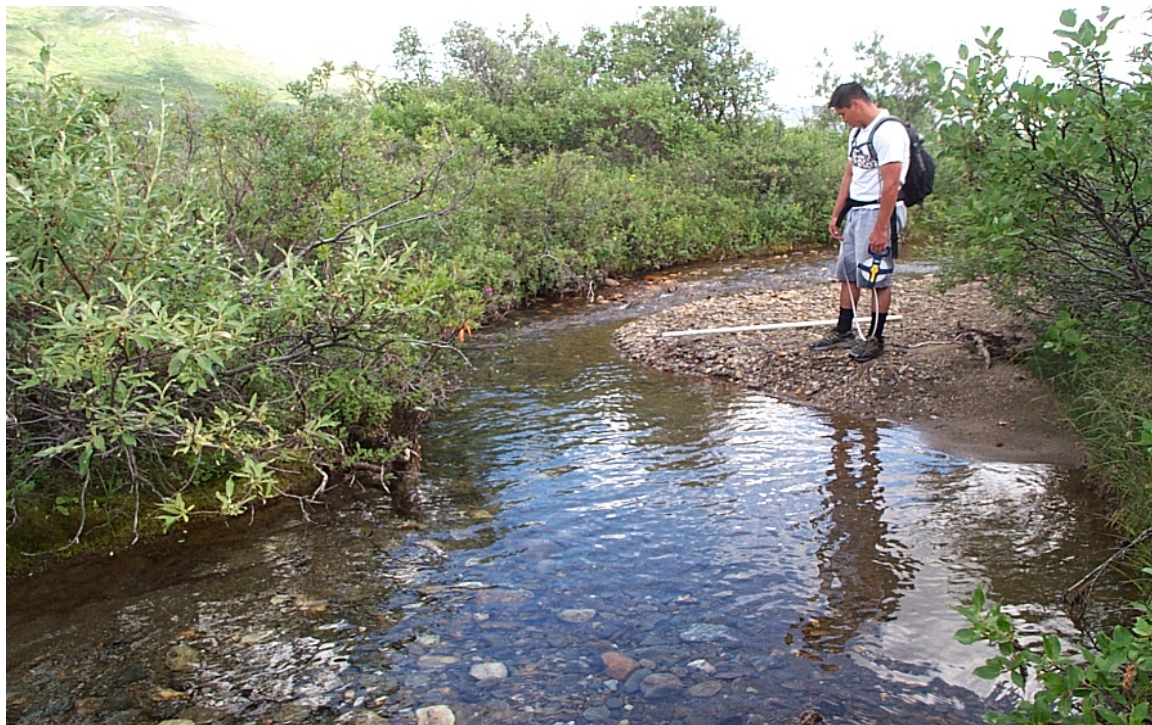
Photo 43. Upstream view in Darling Creek downstream of Nome-Kougarok Road culvert.

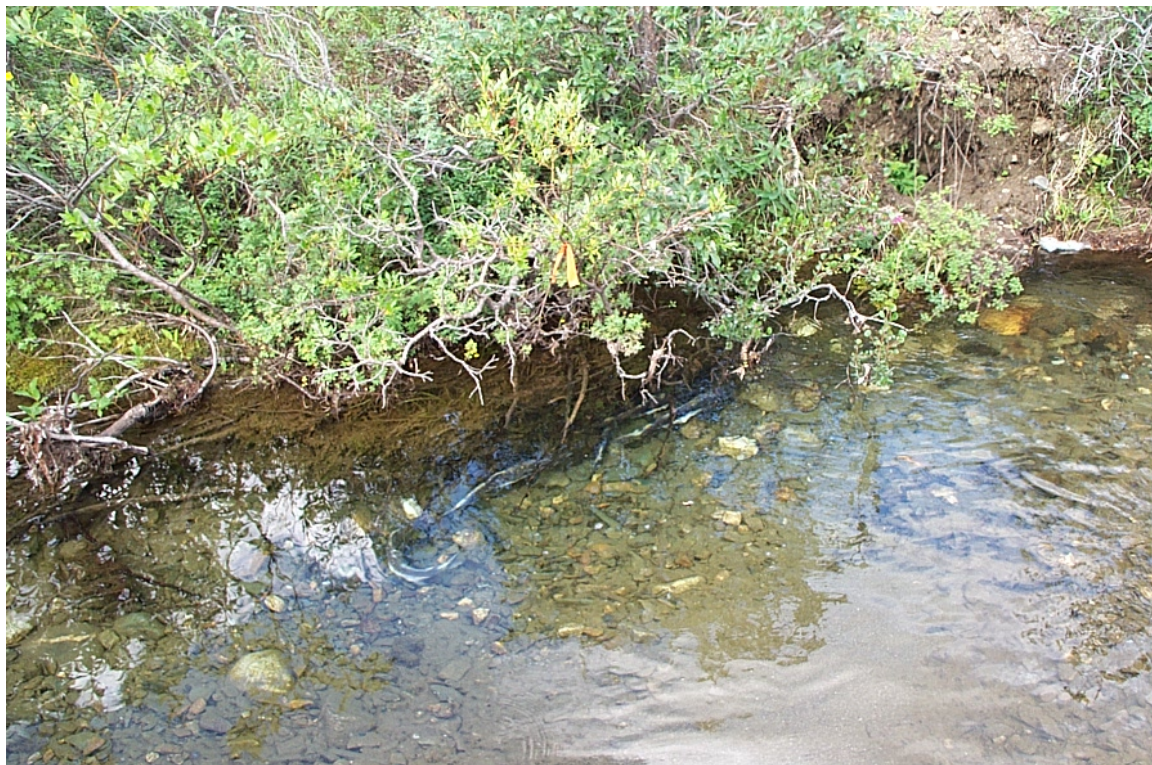
Photo 45. Pink salmon holding in cover of undercut bank and over-vegetation and SWD.

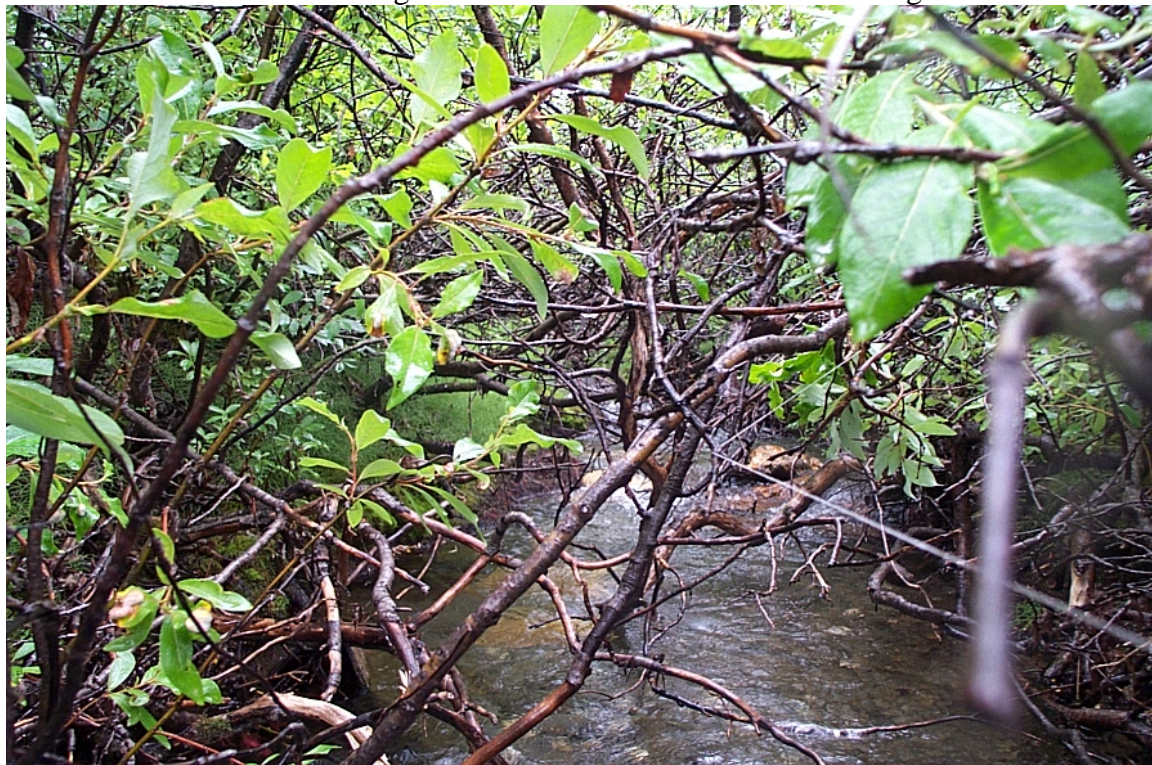
Photo 46. Upstream view in Rocky Mountain Creek at channel and canopy cover.

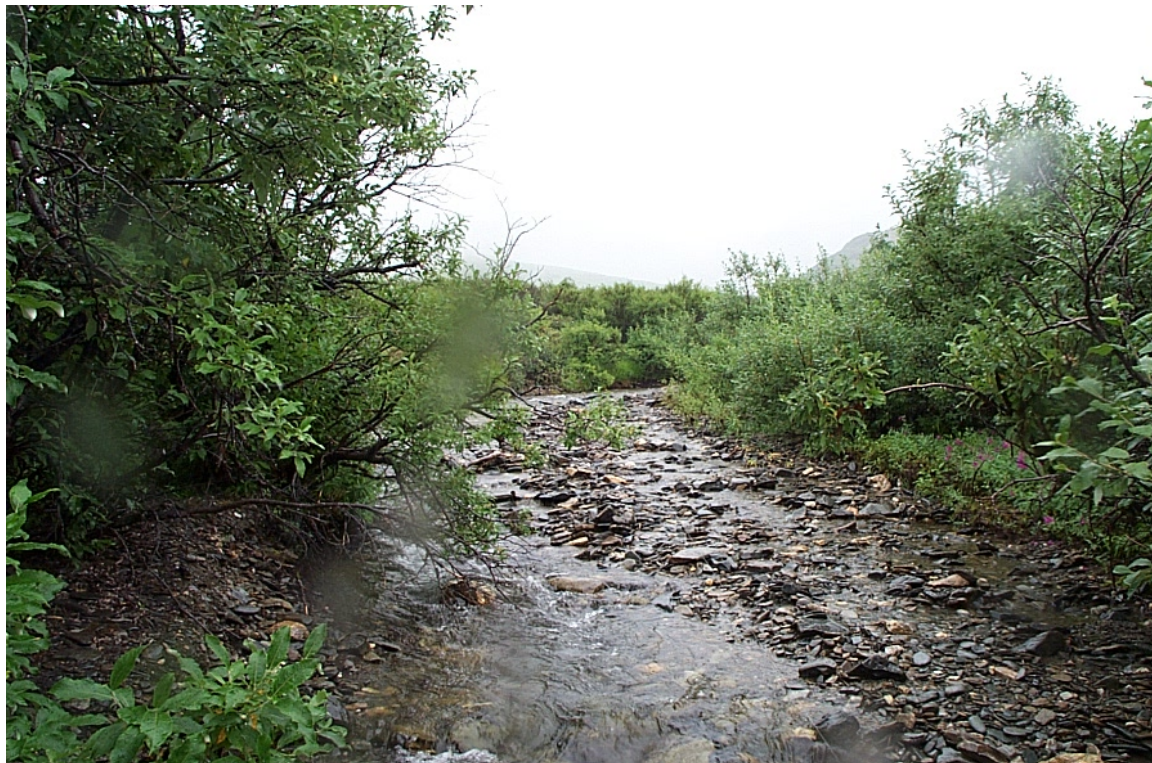
The surveyed portion of Reach C1 extends 600 m upstream from the Nome River or 141 m upstream of the culverted road crossing (Photo 51). Channel pattern is sinuous. Mean gradient is 2.4%. Channel type is riffle-pool morphology with 76.6% gravel-cobble substrate (RPg-c, Hogan et al. 1996). Substrate composition is 48.2% gravel, 28.4% cobble, 20.3% fines and 2.4% boulder. Mean bankfull width and depth are 8.8 m and 0.7 m, respectively. Habitat type is primarily riffle at 75.4%, followed by 13.2% glide and 11.1% pool. Total instream cover is 9.7%; major cover components are small woody debris (3.5%) and boulder (2.4%). Overhanging willow vegetation is the dominant overhead cover element in riffle (11.1%) and glide (3.7%) habitats. Channel disturbance indicators include; bank erosion, denuded bars, and elevated mid-channel bars.

Photo 51. Downstream view of undersized culvert at Christian Creek.

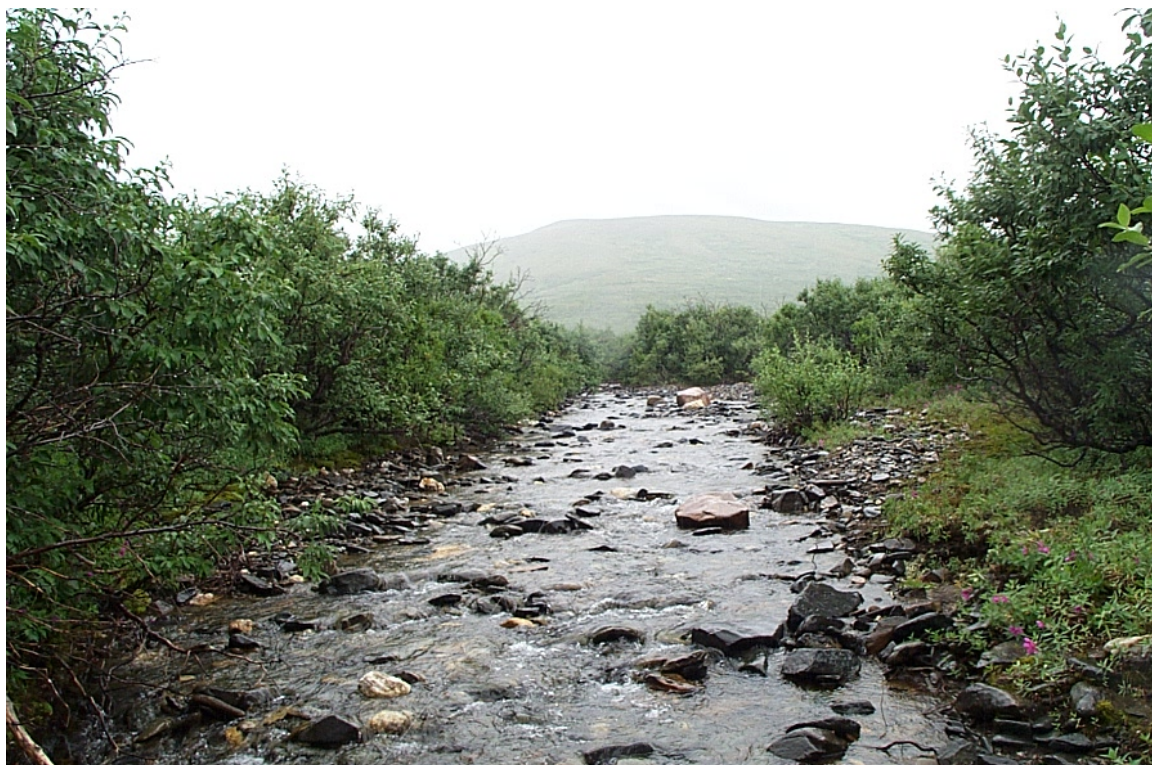
Photo 52. Upstream view in Christian Creek at chainage 0+300 m.

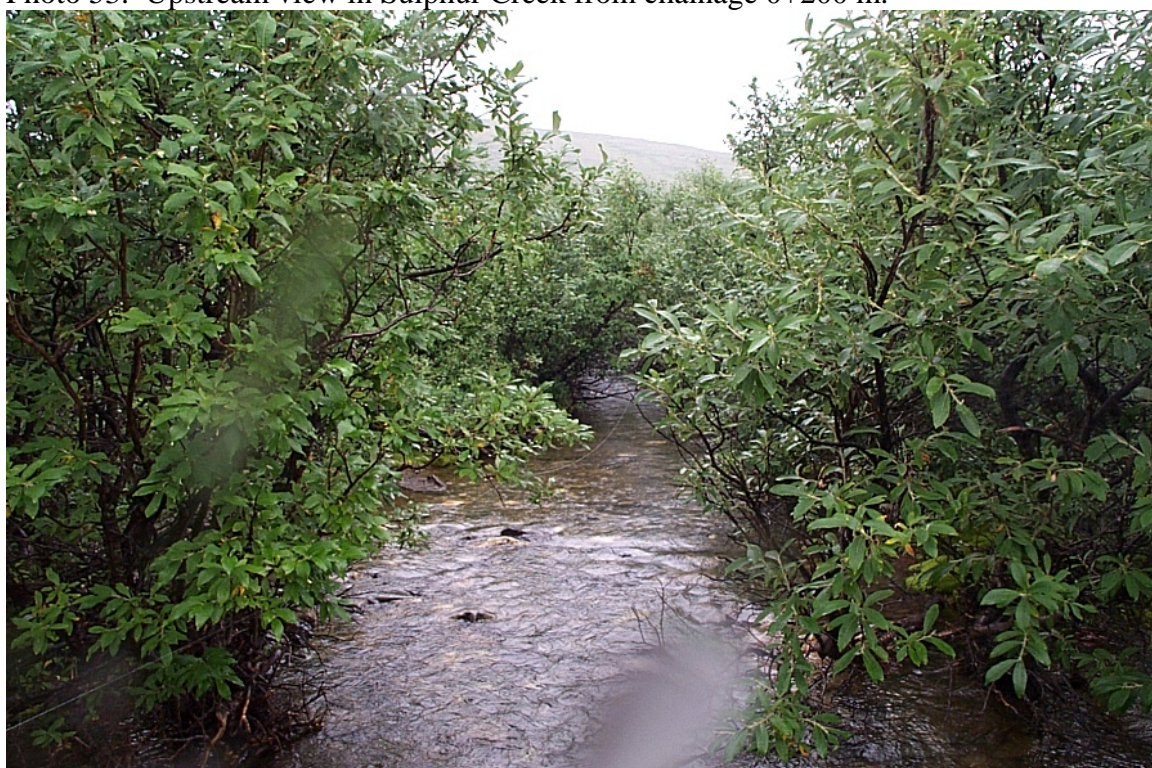
Photo 53. Upstream view in Sulphur Creek from chainage 0+200 m.
